# ***Nomad***

# ALERT SERVICE BULLETIN

## **ELECTRICAL POWER – DC GENERATION GENERATOR CABLE INSPECTION AT FIREWALL AND FEED THROUGH STUD MODIFICATION (MOD N724)**

Record compliance with Alert Service Bulletin ANMD-24-5, Parts 1, 2 or 3 as appropriate in the airframe log book.

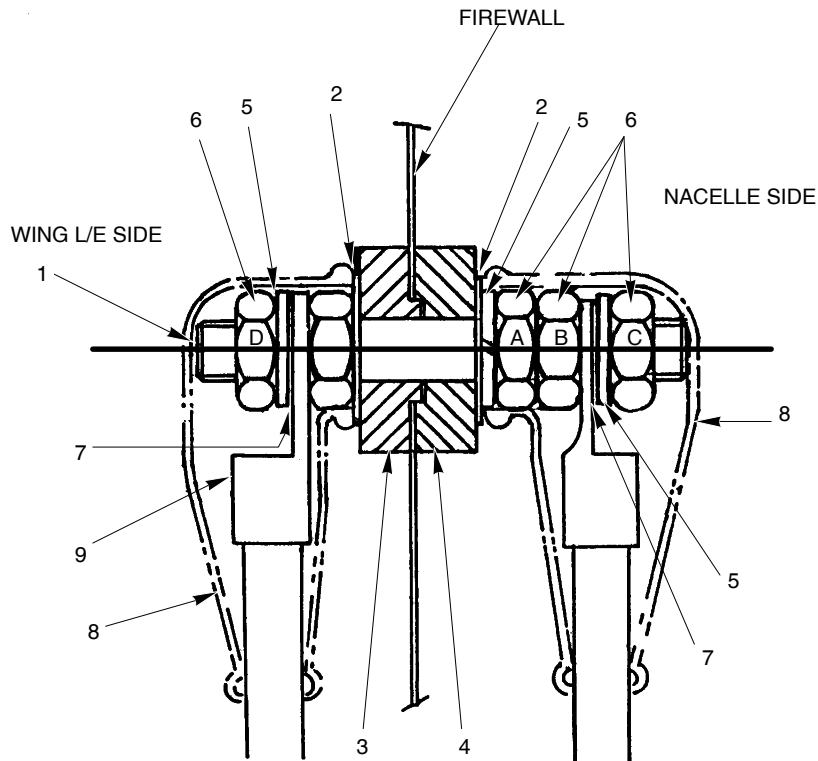
Figure 1 Generator Cables and Stud Assembly

An instance has occurred in which the terminal lug on the generator cable in the wing leading edge at the engine firewall was severely damaged by overheating. Mod N724 is introduced to overcome this hazard. It should be noted that Mod N724 applies to the connection in the Generator circuit only. An identical connection assembly is used in the Starter circuit, but is unaffected by this modification.

Mod N724 is introduced. This modification replaces existing Stud PN I/N-81-424 with a copper stud, PN I/N-81-925, using brass nuts. The increased electrical conductivity of the new assembly eliminates overheating problems, giving increased life to the generator cable connections in this area.

- (4) Re assemble the replacement stud PN I/N-81-925, observing the following sequence:-  
(all item numbers refer to Fig.1.)
  - (a) Assemble Special Washer, item 2, and Insulating Washer, item 3, on to the longer end of the new copper stud, item 1.

- (b) Insert the stud through the firewall, from the wing leading edge side, and add Insulating Washer, item 4, and Special Washer, item 2, followed by Spring Washer, item 5, and Nut, item 6A. Before running Nut, item 6A, fully home, apply Loctite 242 Nutlock to the threads on the copper stud, then tighten the nut to 20 inch pounds. Preparation, application and curing of the Loctite should be in accordance with the manufacturers instructions.
- (c) Assemble Locknut, item 6B, and tighten against item 6A to a Torque of 80 inch pounds.

- (d) Assemble the cable terminal lug, followed by Washer item 7, Spring Washer item 5, and Nut item 6C, and Torque tighten to 60 inch pounds, against Locknut item 6B. Replace the protective cover, item 8.
- (e) At the other end of the stud, on the wing leading edge side of the firewall, assemble the cable terminal lug, followed by Washer item 7, Spring Washer item 5, and Nut item 6D; torque tighten to 60 inch pounds against the stud hexagon. Replace the protective cover, item 8.
- (f) Remove the warning placard applied in accordance with PART 2.
- (g) Reconnect the battery and at the next engine start check Generator operation as per the "After Start" checks in Section 3 of the Flight Manual.
