AeroSpace Technologies  
of Australia Pty Ltd  
(Incorporated in ACT)

SUBJECT: NOMAD ALERT SERVICE BULLETIN ANMD-53-9

FUSELAGE - RUDDER PEDAL GUARD -  
RELOCATION OF BRUSH SEALS (MOD N728)

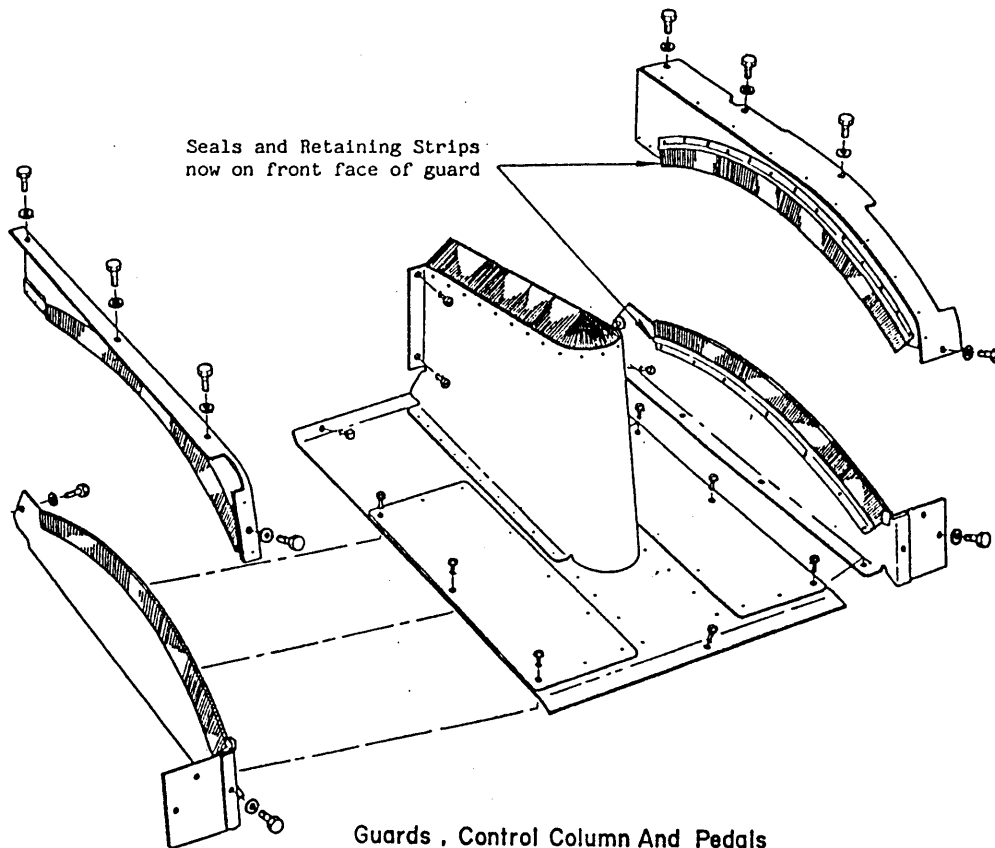
Guards, Control Column And Pedals  
LH/RH  
Figure 1

The bolt connecting the Brake Actuating Arm to the Pivot Arm caught on the Pilot's RH Rudder Pedal Upper Guard causing the pedal to jam in the forward position.

The upper and lower brush seals and their retaining strips are removed from the rear, or hidden faces of the rudder pedal guards, and re-located on the front, or visible faces. Attaching rivets are flush countersunk on the rear faces of the guards.

- D. Countersink the holes for the attaching rivets on the rear face of the guards (i.e. the hidden face when the guard is installed).
- E. Chamfer the edges of the curved slot on the rear face, approximately 0.03 inch by 45 degrees. Do not chamfer the end radii of the slot.
- F. Re-attach the brush seals and retaining strips using rivets such that the seals and retaining strips are now on the front face of the pedal guards, and the rivet tails are flush riveted in the countersinks on the rear face. (Refer Fig. 1)
