# Nomad

# SERVICE BULLETIN

## FORWARD CABIN WINDOWS – IMPACT RESISTANT TRANSPARENCIES – MOD N452

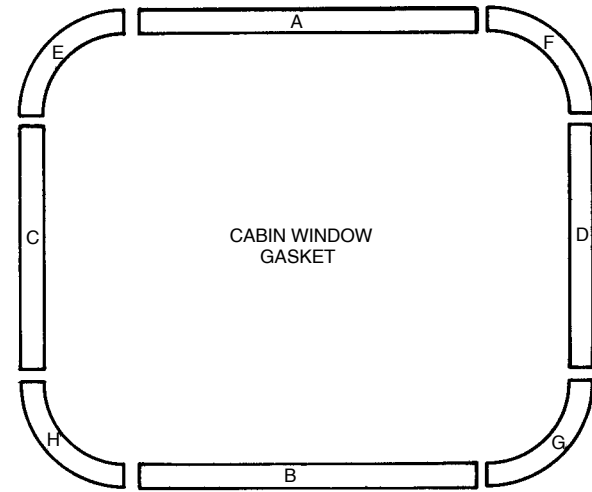
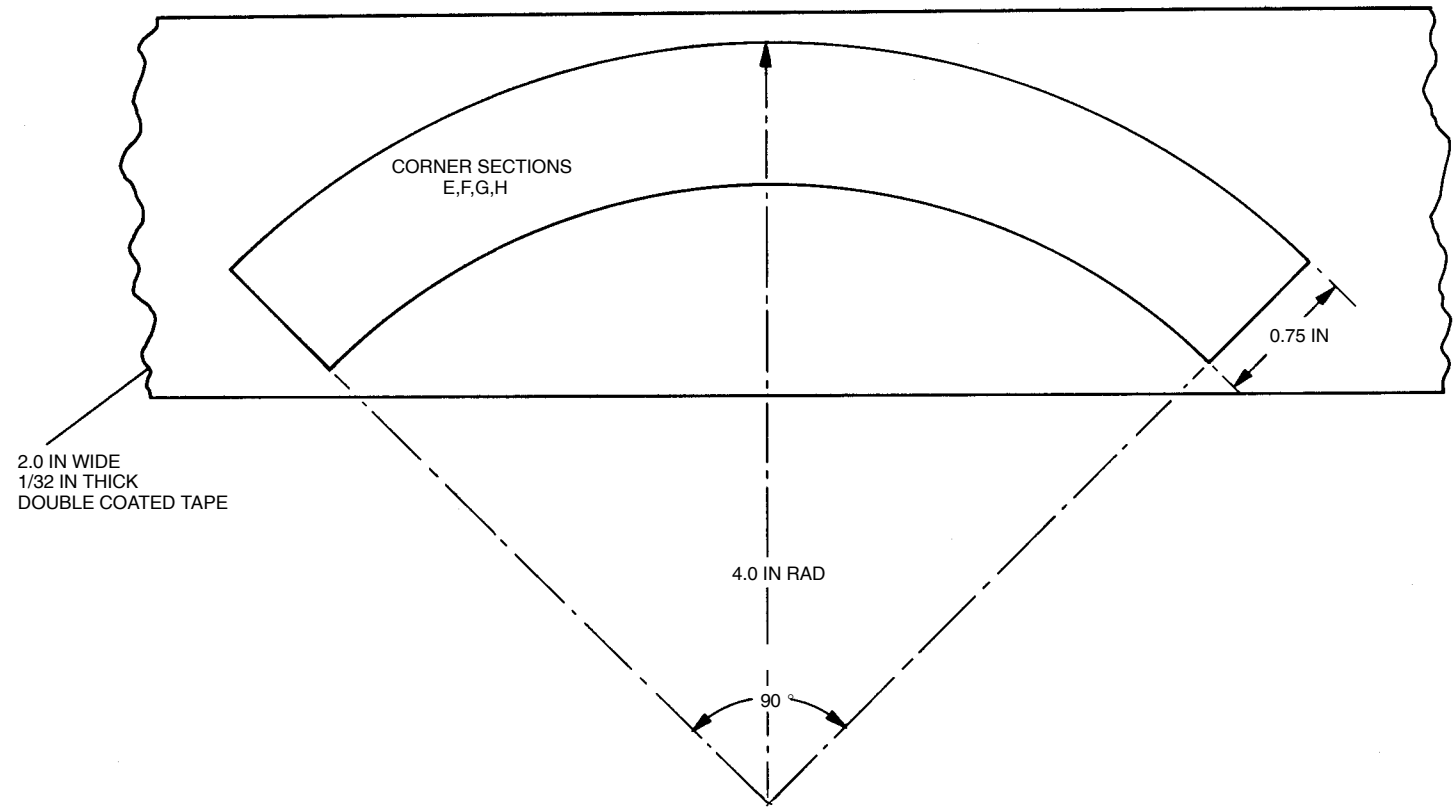
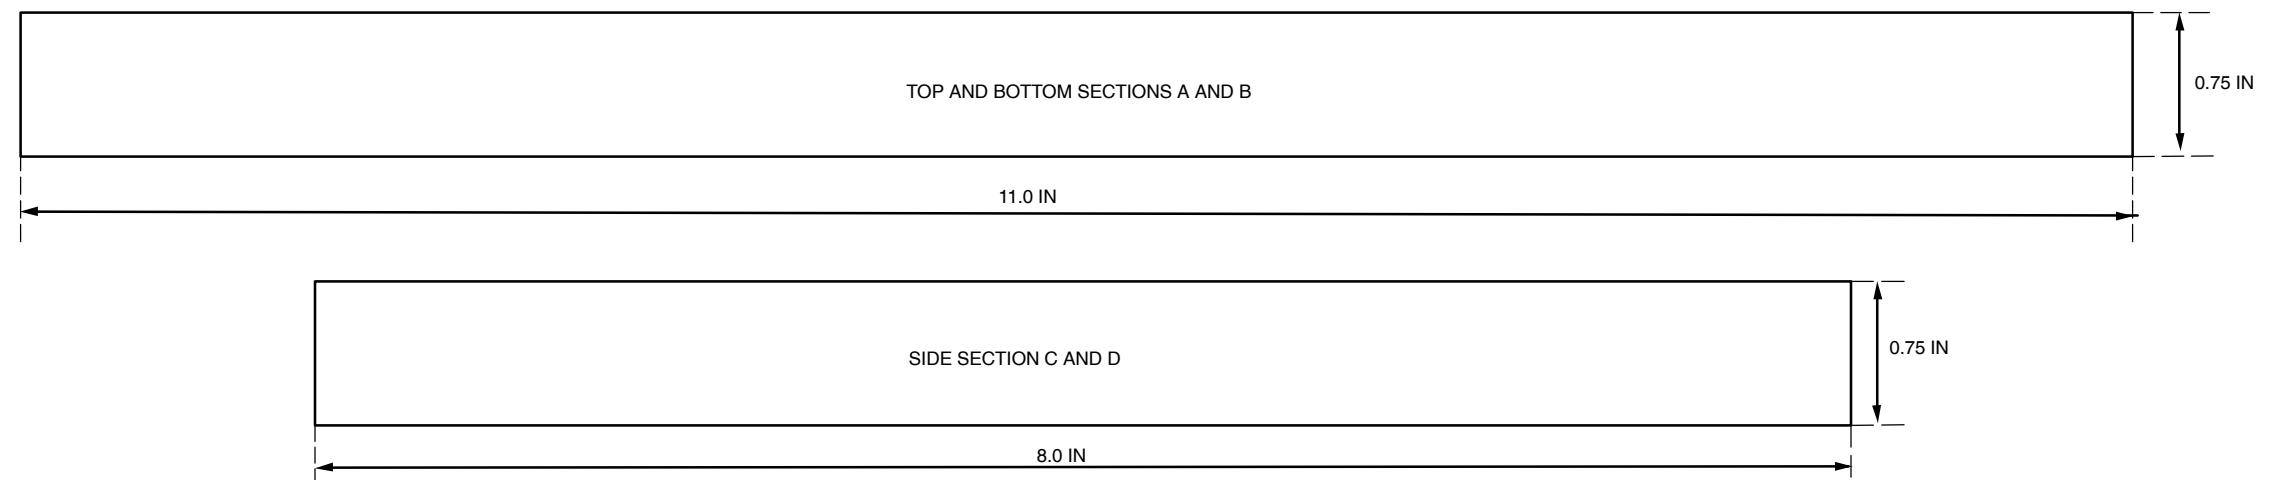
Figure 1 Templates for Manufacture of Cabin Window Gasket

Double sided adhesive gaskets are manufactured from PN 4032 Scotchmount double coated adhesive tape 2 inches wide and 1/32 inch thick using the templates in Figure 1.

- (4) When the cleaned surfaces are dry, remove the protective paper from one side of the eight new sections of the Scotchmount double sided adhesive gaskets and adhere them to the inner surface of the fuselage skin around the window aperture.

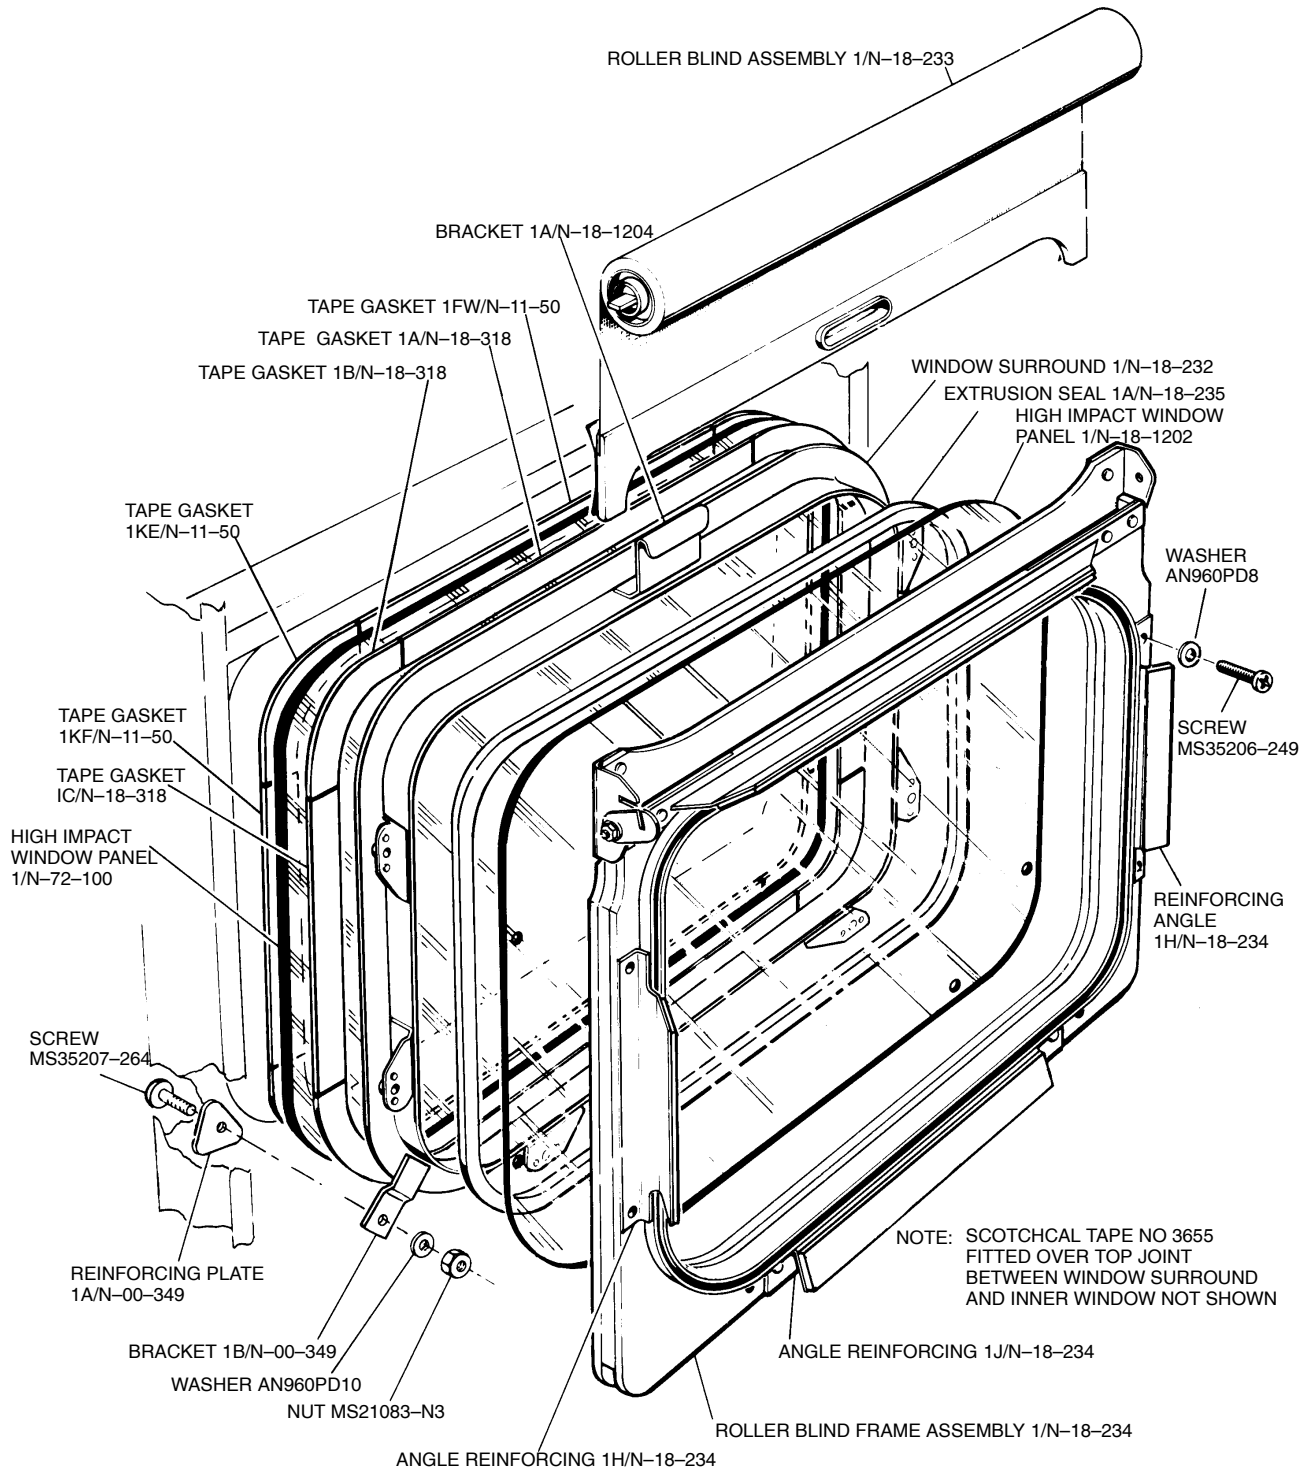
**Figure 2 Window Installation**

N24-Series aircraft have the forward cabin windows in line with the plane of rotation of the propellers. An incident has occurred in which ice, shed from a propeller, broke the adjacent forward cabin window and entered the cabin.

The forward outer and inner passenger cabin windows at Sta 150.0 are replaced by windows made of 0.125 inch thick, clear high impact resistant polycarbonate material.

#### B. Install the High Impact Polycarbonate Windows (Ref Figure 2)

- (5) Remove the protective paper from the other side of the gaskets, align the new high impact polycarbonate outer window panel with the position marks on the inner surface of the fuselage skin and apply firm pressure around the edges of the window panel and the window aperture to ensure satisfactory adhesion of the window panel to the fuselage skin.
- (6) Apply a fillet of PR1221B or PR1222B sealing compound around the external joint between the fuselage skin and the outer window panel. The fillet is not to extend more than 1/16 inch beyond the edge of the skin onto the window panel.

- (7) Clean the internal surface of the outer window panel.
- (8) Secure the window surround to the outer window panel by removing the protective paper from one side of the double sided adhesive gaskets and pressing them firmly in position on the outer face of the window surround. Remove the protective paper from the other side of the adhesive gaskets and then press the window surround firmly into position on the outer window panel, ensuring that good adhesion is obtained. Using the brackets, new screws, washers and new self-locking nuts (Ref Service Bulletin NMD-56-4), secure the window surround and the outer window panel to the fuselage skin. Torque tighten the self-locking nuts to between 12 and 15 pound inches.
