SB-GA8-2008-41

Issue 2

Service Bulletin

Alternate Airbox Upgrade.

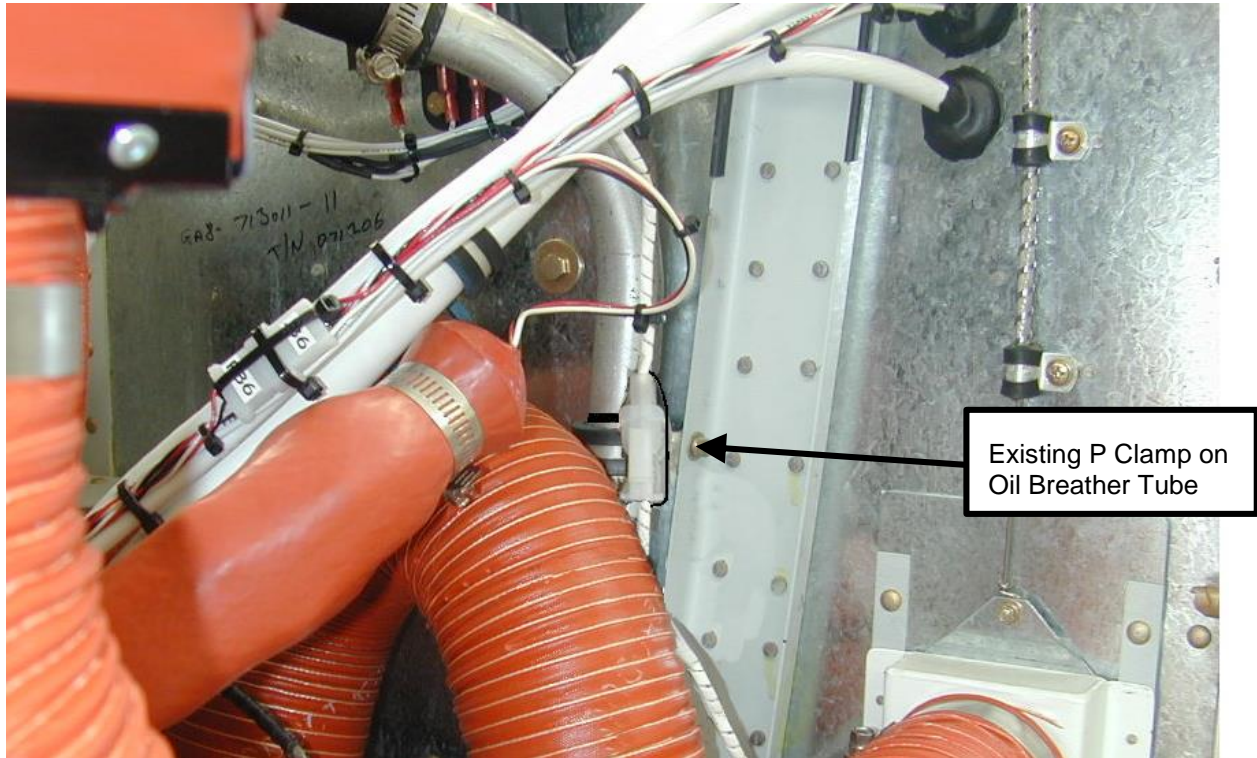
Figure 5: Modified configuration. Additional cable ties are not shown.

19. Plug in and secure the alternate air warning connectors (P26/J26) per Figure 5 and Figure 6. Confirm that the alternate air indicator illuminates with activation of the by-pass door. This can be achieved by opening and closing (pushing and pulling) the Alternate Air Control Cable to initialise the sensor circuit.
20. Reinstall any panels, cowls, etc, removed to gain access in accordance with the GA8 Service Manual.

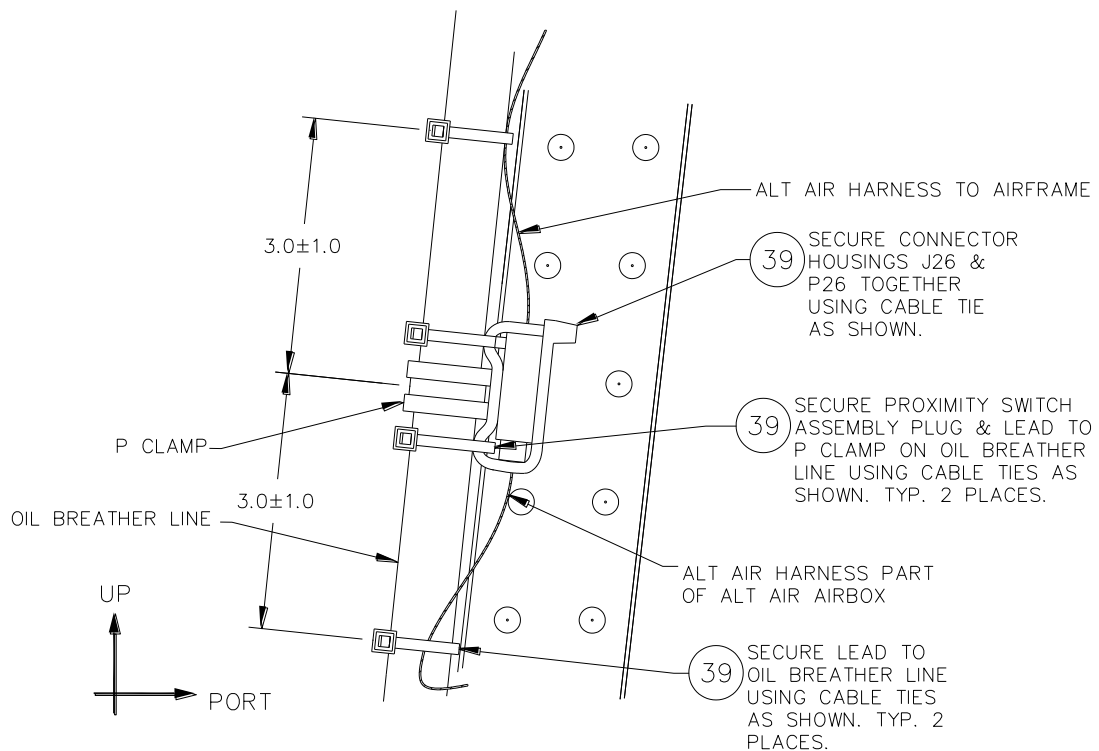
Figure 6: Detailed View of the attachment of the P26/J26 Electrical Connector (Looking Aft onto Firewall).
