SB-GA8-2019-195

Service Bulletin

Relocation of Alternate Air Induction Electrical Connection

AIRCRAFT	SERIAL NUMBER(s)
GA8	Serial Numbers GA8-00-004 through GA8-07-114 that have been modified by SB-GA8-2008-41 Issue 1
	Serial Numbers GA8-07-115 through GA8-18-248

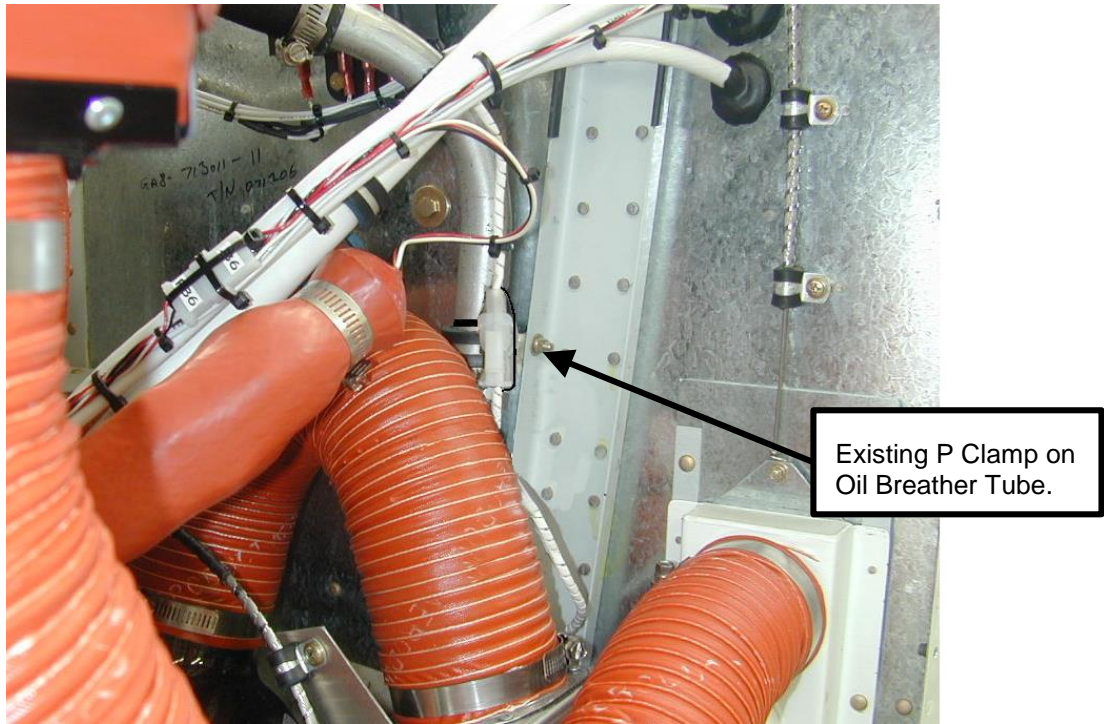
The existing restraint of the Alternate Air Induction Harness connector has been found to result in accelerated aging of the associated wiring due to vibration. This Service Bulletin addresses this issue by relocating the connector and securing it to rigid structure.

Figure 1: Modified configuration. Additional cable ties are not shown.

5. Secure harness connector to P Clamp / Oil Breather Tube as identified in Figure 1. Restrain with Item 1 per Figure 2. Trim all cable tie tails flush.

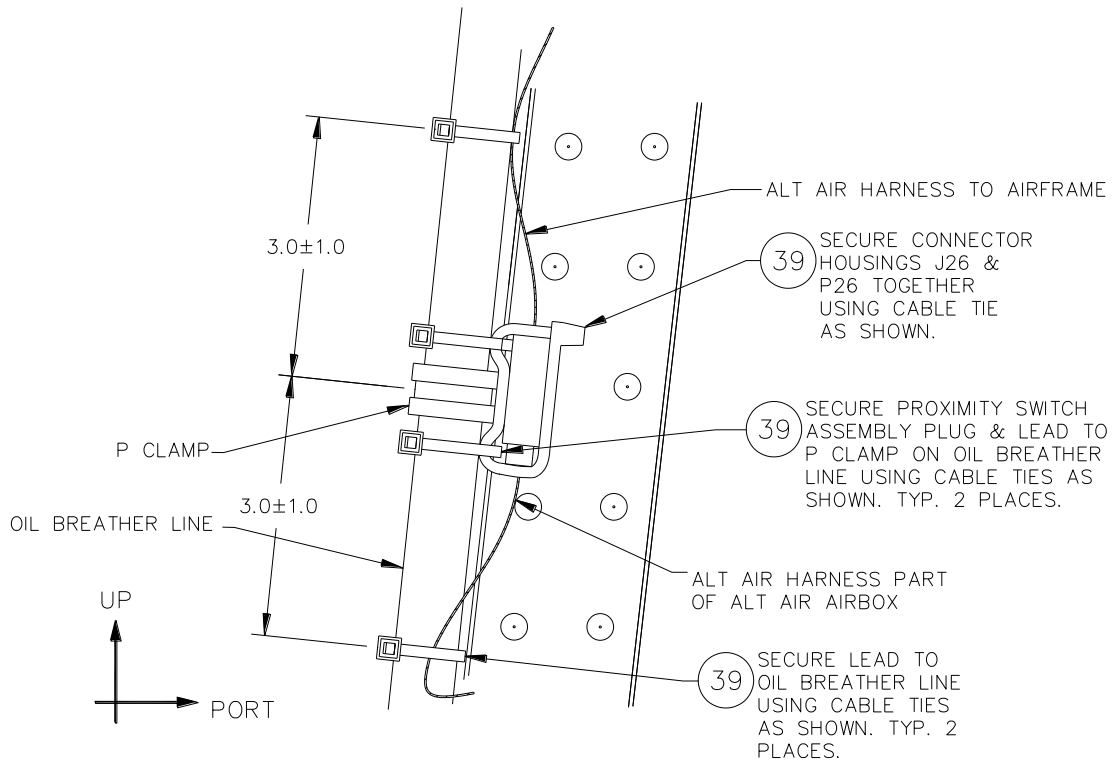
Figure 2: Detailed View of the attachment of the P26/J26 Electrical Connector (Looking Aft onto Firewall).
