Service Bulletin

Replacement of UniPoint SNLS-135 starter solenoid with Lamar STS-S12 starter solenoid.

SB-GA8-2019-197

Issue 1

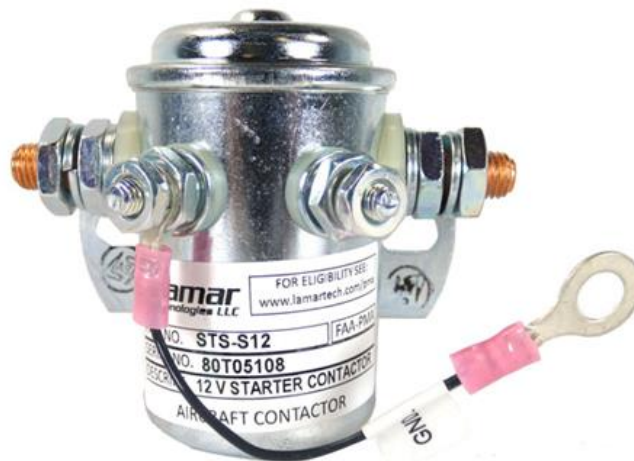
Figure 1 – Lamar starter solenoid

The UniPoint SNLS-135 starter solenoid is installed in the underfloor solenoid box. The part can no longer be sourced by GippsAero and so the “on condition” replacement of the part with a Lamar PMA P/No. STS-S12 solenoid is authorised by this Service Bulletin.

The change is applicable to Solenoid Box P/No. GA8-246012-111. As the STS-S12 is not a “drop-in replacement” for the UniPoint SNLS-135 solenoid the solenoid box and the GP Start Bus (located in the solenoid box) require modification. Note that the UniPoint SNLS-135 cannot be re-fitted to the solenoid box after completing this Service Bulletin.

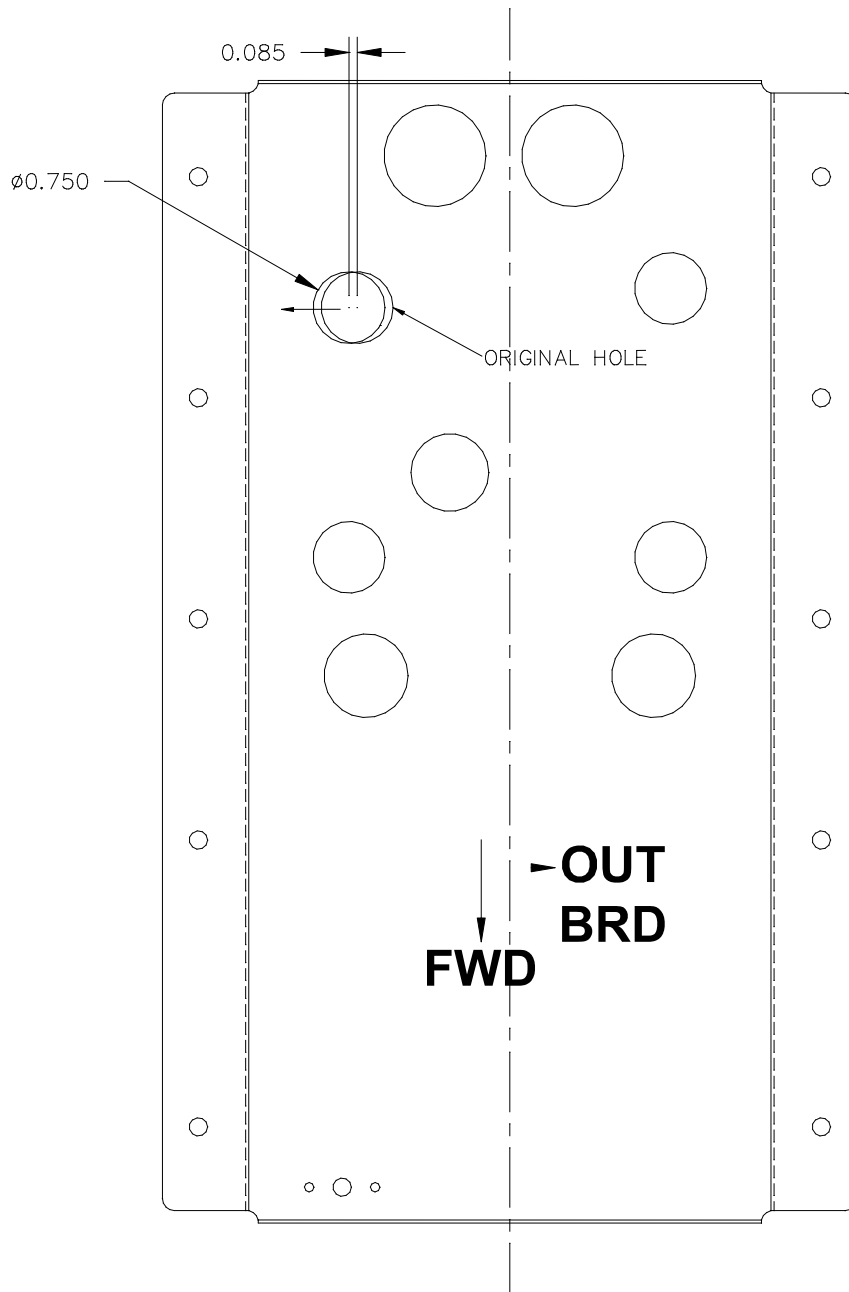
**Figure 5 – Modification to the floor of the solenoid box.
(Viewed looking down into the enclosure.)**

- 1.3.4 The lower fasteners for the Bus 1 and Starter solenoids are secured with an anchor nut retainer. This is to be replaced with Item 2.
- 1.3.5 De-rivet the anchor nut retainer as indicated by arrows in Figure 4. This is on the inboard side of the solenoid box.
- 1.3.6 Elongate the hole in the base of the solenoid box as shown in Figure 5.
- 1.3.7 Elongate the two holes in the starter solenoid side of the box as shown in Figure 6.
- 1.3.8 Restore surface protection to holes using Compound C1 (Table 3).
- 1.3.9 Replace retainer with Item 2 using rivets Item 7. Orient rivet heads to the outside of the box as shown in Figure 4. Note that Item 2 is **not** symmetric about the rivet holes and correct orientation must be confirmed before riveting.

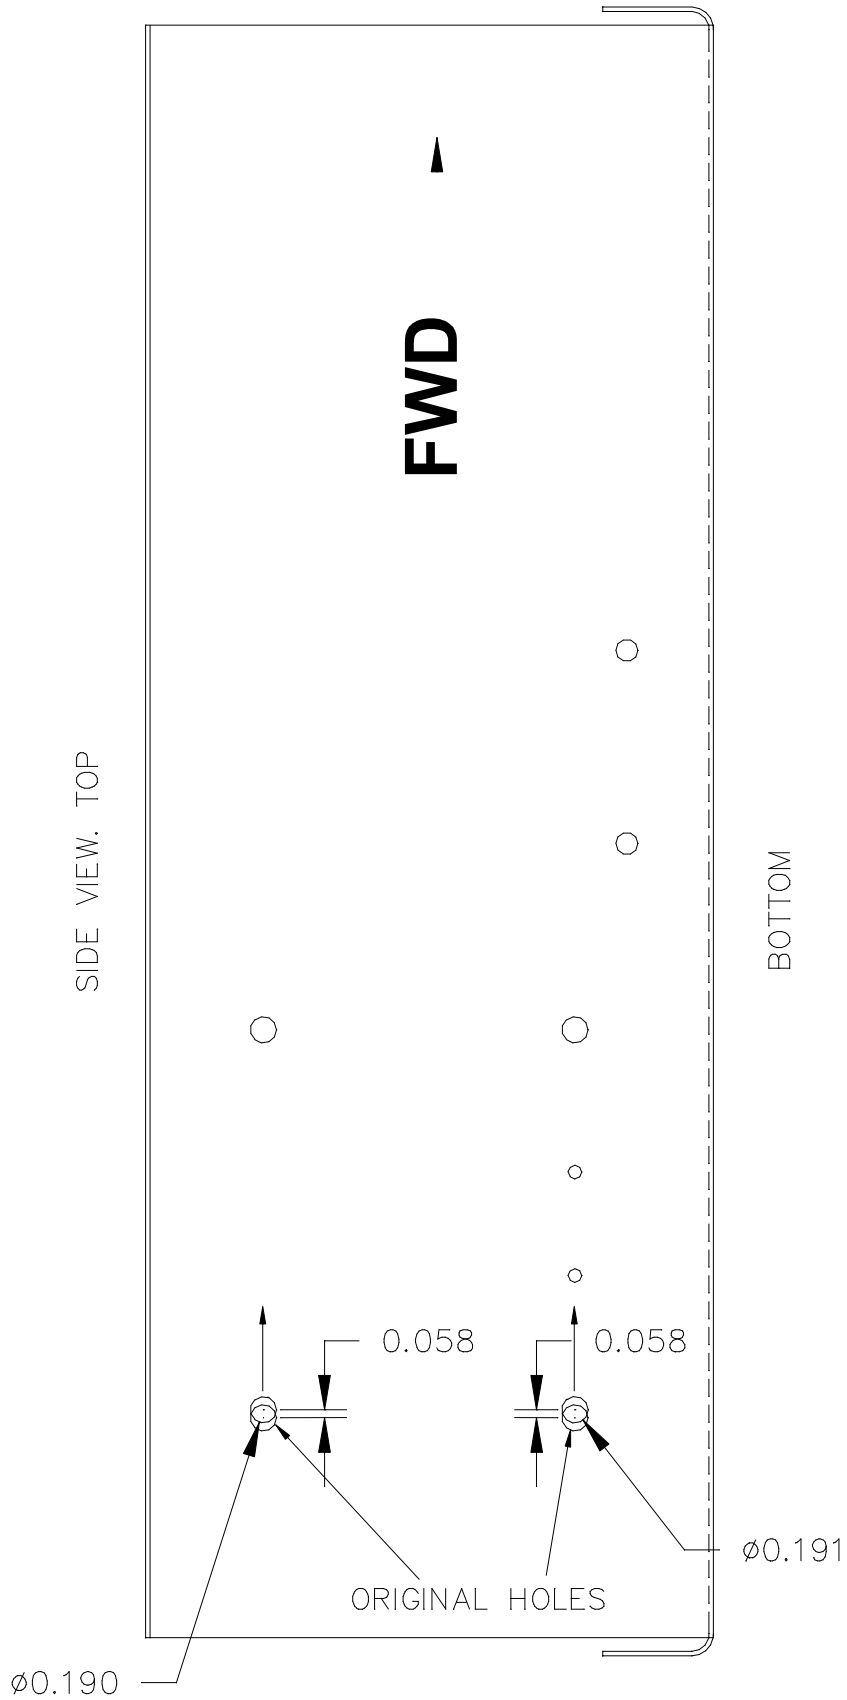
**Figure 6 – Modification to side of enclosure. Starter Solenoid side.
(Viewed looking towards the enclosure, inboard side.)**

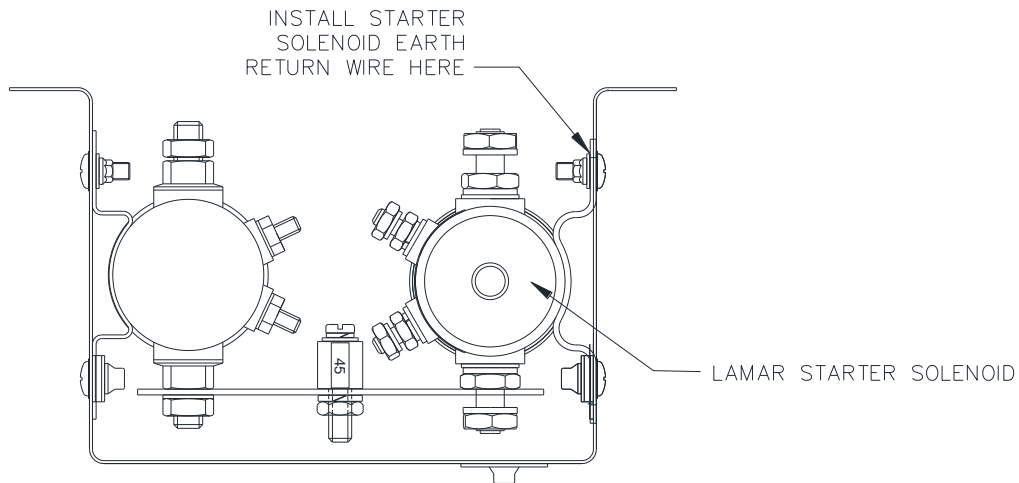
Figure 11 – Side view showing earthing point for starter solenoid to the box.

- 1.5.6 This wire shall be placed in the locations as directed by Figure 11 & Figure 12.
- 1.5.7 An additional earth wire is installed which has been denoted PE5A18N. Install this to the solenoid box as noted in Figure 13. The other end of this wire will be terminated after the solenoid box has been re-installed in the aircraft.

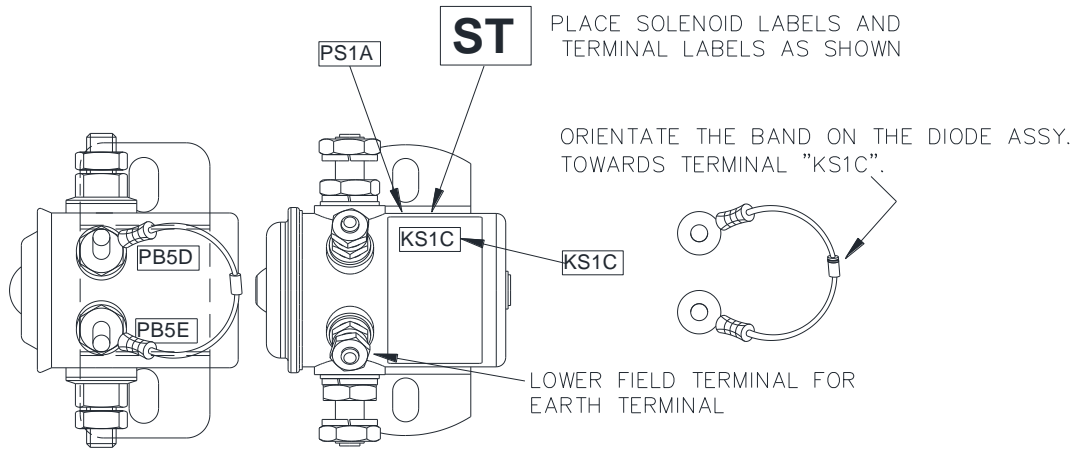
Figure 12 - Location for placement of solenoid starter earth return.
