SB-GA8-2021-198

Issue 1

Service Bulletin

GA8 Fuel Return Line Inspection

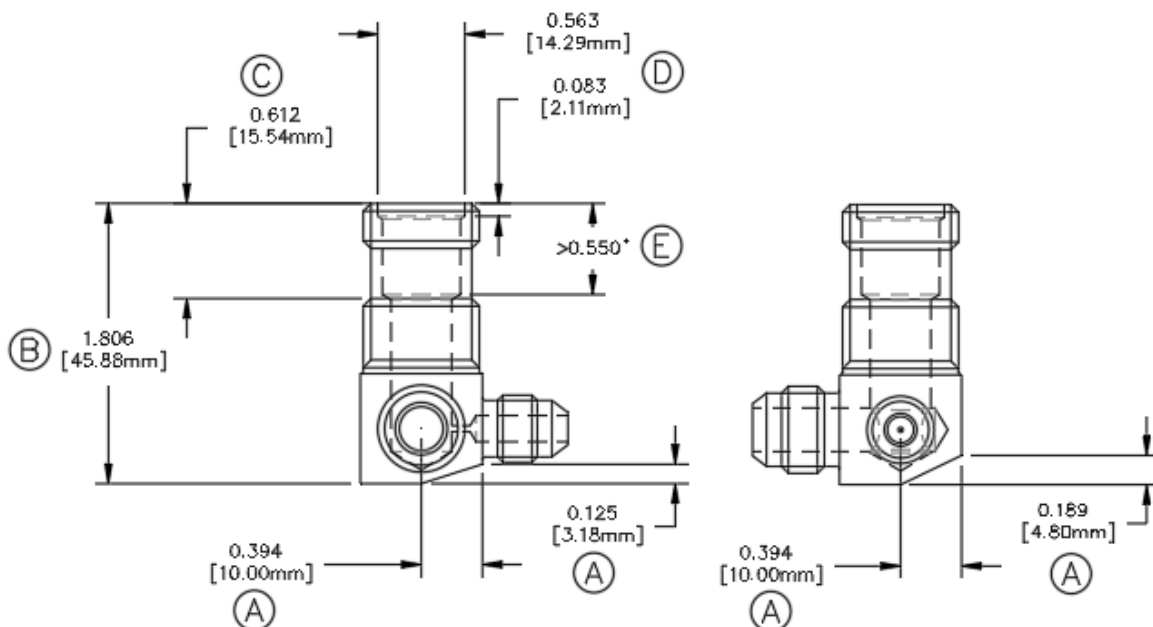
Figure 1: Fitting Modification

An operator has reported a loss of clearance between the Nose Leg Steering Arm and the 3 way fuel system fitting located under the fuel servo. This Service Bulletin gives inspection and modification procedures which allow continued operations with 100 hour inspections. The terminating action is by achieving a 0.312" clearance between the fitting and the Steering Arm.

6. Using appropriate austenitic stainless steel machining tools carry out the following alterations to the fitting as shown in Figure 1.
 - A. Chamfer the corners of the fitting to the dimensions shown as (A). If this step results in sufficient clearance, then steps B through E may be omitted.

- B. Shorten the fitting approx. 0.025" to the dimension shown as (B).
 - C. Machine off approx. 0.125" of the thread where the nut is installed so that the plain portion for the O-ring is to the dimension shown as (C).

- D. Using a standard 118° Ø9/16 drill, counterbore the filter hole 0.083" deep as shown as (D). Break the sharp edge.
 - E. Ensure the filter "cup" depth is greater than 0.550" as shown as (E). If the depth is insufficient, machine or drill the hole using a 0.504 [12.80mm] drill to a depth of 0.587 [14.91mm].

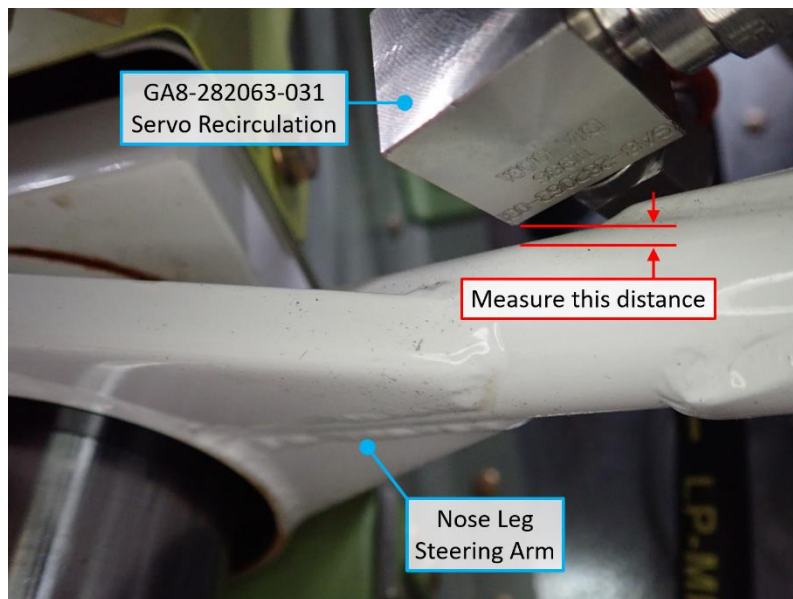
Figure 2: View of area with minimum clearance.

1. Confirm engine Dynafocal mounts are still within wear limits (Refer to GA8 Service Manual Section 71-20-00).
2. Inspect the nose leg steering arm and the Servo Recirculation fitting on the bottom of the fuel injection servo for evidence of contact. If contact is found modify the fitting as below or replace with a GA8-282063-131 fitting. Restore the paint finish on the nose leg steering arm in accordance with the GA8 Service Manual.
3. With the nose wheel turned to the right at full lock, measure the clearance between the Servo Recirculation fitting and nose leg steering arm as shown in Figure 2. Carry out the appropriate action listed in Table 3;

Initial Clearance Measured	Initial Action	Clearance Measured After Initial Action	Additional Action	Terminate SB
Any	Replace with -131	>0.312"	Nil	Yes
		> 0.125" < 0.312"	Inspect each 100 hrs	No
< 0.060" or Visible contact	Modify existing -031 fitting and Check Engine mount wear.	< 0.125"	Replace with -131	Yes*
0.060" to 0.125"	Modify existing -031 fitting within 100hrs	> 0.125" < 0.312"	Inspect each 100 hrs	No
0.125" to 0.312"	Nil			
0.125" to 0.312"	Modify existing -031 fitting.	> 0.312"	Nil	Yes
	Nil			
> 0.312"	Nil
