SB-GA8-2021-209

Issue 1

Service Bulletin

Tow Limit Markings

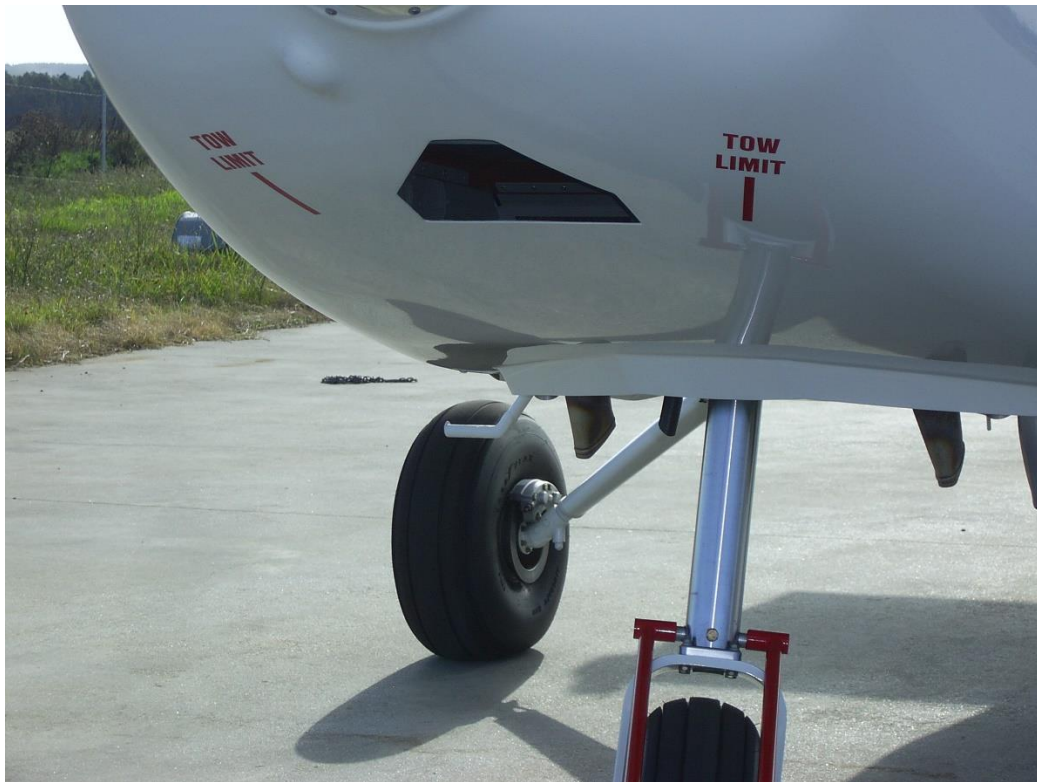
Figure 1 – Tow Limit Markings on Lower Engine Cowl

This Mandatory Service Bulletin details the installation of Tow Limit Markings previously contained in Service Letter SL-GA8-2007-07, which was an optional modification. The Service Letter stipulated that these markings were required when owners and operators utilised motorised towing equipment to prevent over travel and damage to the nose wheel steering stops and/or rudder system. Recently an operator used motorised towing equipment without incorporating the Service Letter resulting in minor damage to the nose leg steering stops. Therefore the requirement to install Tow Limit Markings is being made mandatory by this Service Bulletin.

2. Lift the handle of the tow bar to the lower engine cowl and mark the location just inside the extreme position by approximately 0.25" +/- 0.125".
3. Affix item 1 at each marked location. Ensuring the tow limit line coincides with the marking. Refer to Figure 1.
4. Articulate the nose wheel to confirm the Tow Limit Placards have been attached inside the NLG travel limits. Refer to Figure 2.
5. Visually inspect mechanical stops on the nose wheel steering circuit and rudder surface for any damage and rectify, as required.
