SB-GA8-2021-210

Issue 1

Service Bulletin

Flight Control Circuit Colour Coding

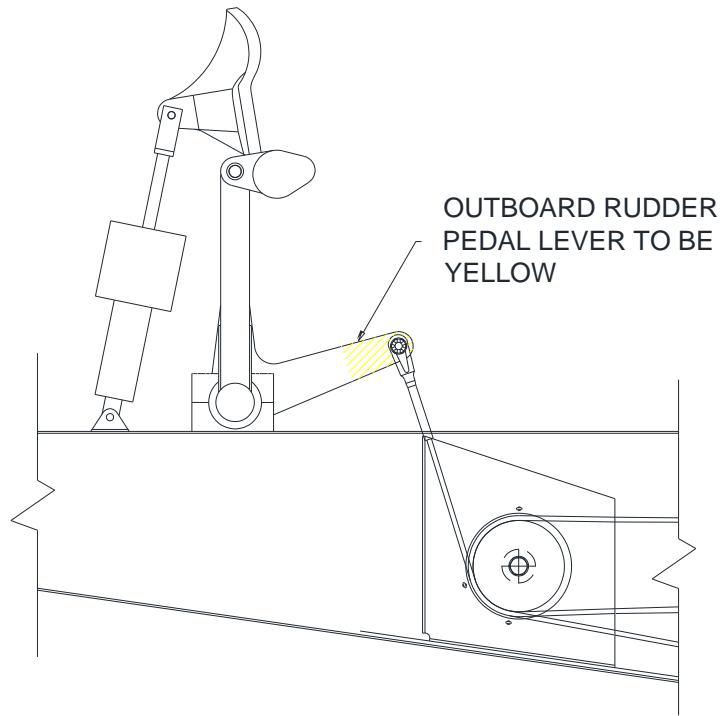
Figure 1 – Outboard Rudder Pedal Lever

2. Inspect the rudder pedal levers and the attaching rudder cables. Check that the outboard rudder pedal lever and cable both have yellow colour coding. Check that the inboard rudder pedal lever and cable both have red colour coding. If correct advance to step 6. Otherwise, carry out the applicable steps 3, 4, and/or 5 as necessary to produce the correct colour coding.

3. Paint the outboard rudder pedal lever with item 1 (YELLOW) as depicted in Figure 1. Avoid painting in proximity to the connection to the rudder cable. The paint should extend approximately two inches along the outboard rudder pedal lever. Ensure any incorrect colour coding is completely obscured or removed.

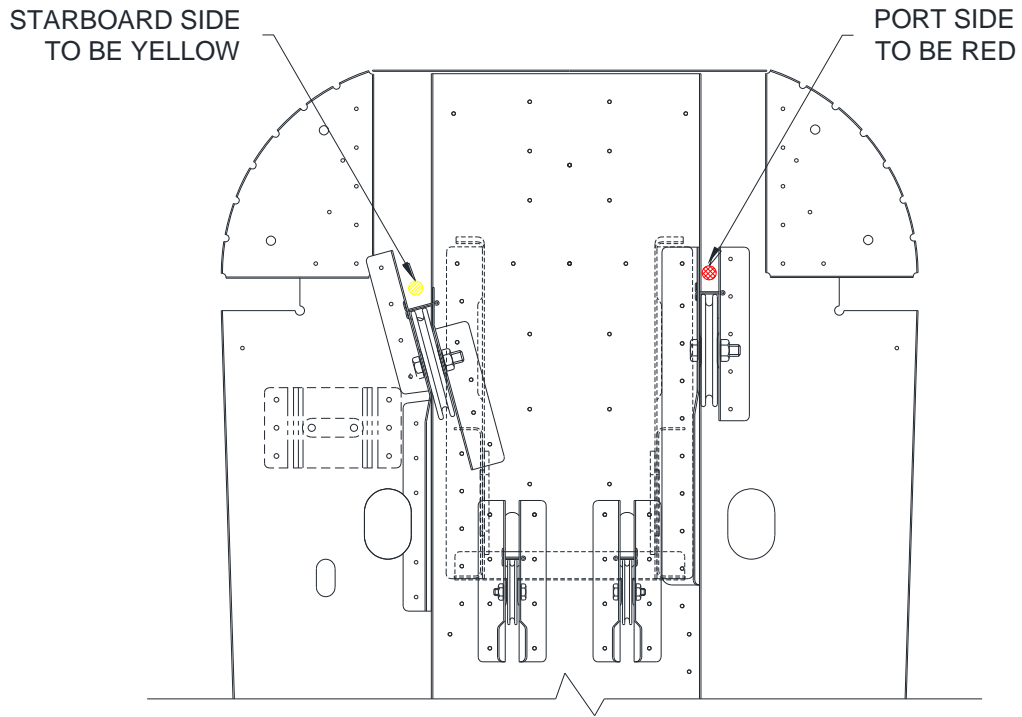
Figure 4 – Bulkhead Assembly

1. Remove the access panel from the underside of the tailcone and stow with hardware.
2. From inside the tail cone, inspect the forward face of the bulkhead at station 229.75 (the bulkhead immediately aft of the elevator walking beam assembly) to ensure the apertures through which the rudder cables route are colour coded correctly. Check above the upper starboard pulley for yellow and the upper port pulley for red. Note the rudder cables cross in the floor at station 57.5 hence the colour coding at the bulkhead will be on opposite sides when compared to the rudder pedals. If correct advance to step 4. Otherwise carry out step 3.

3. Place a small dot of paint of approximately 0.375" diameter using item 1 (YELLOW) above the upper starboard pulley and item 2 (RED) above the upper port pulley as illustrated in Figure 4. Ensure any incorrect colour coding is completely obscured or removed. Note that at the factory the colour coding is embodied as a small rectangular patch around the aperture which cannot be fully applied in the field due to the presence of the pulley brackets.

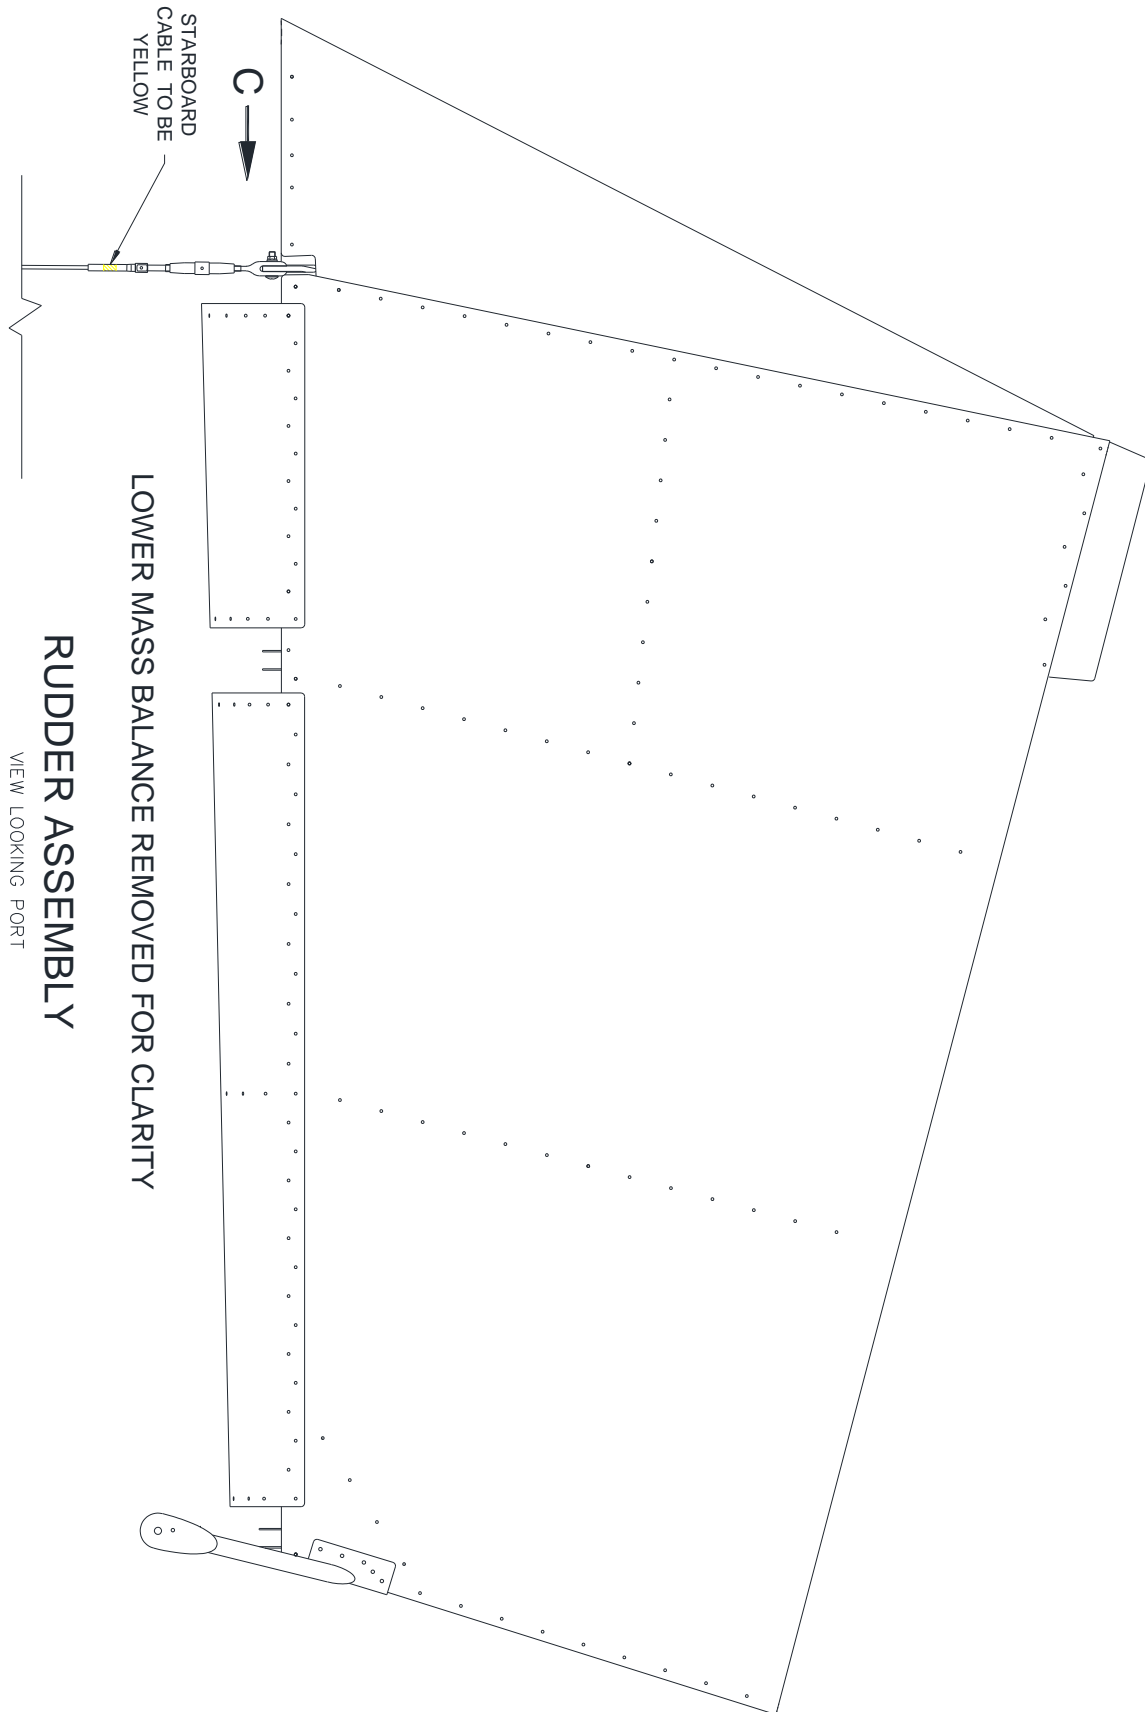
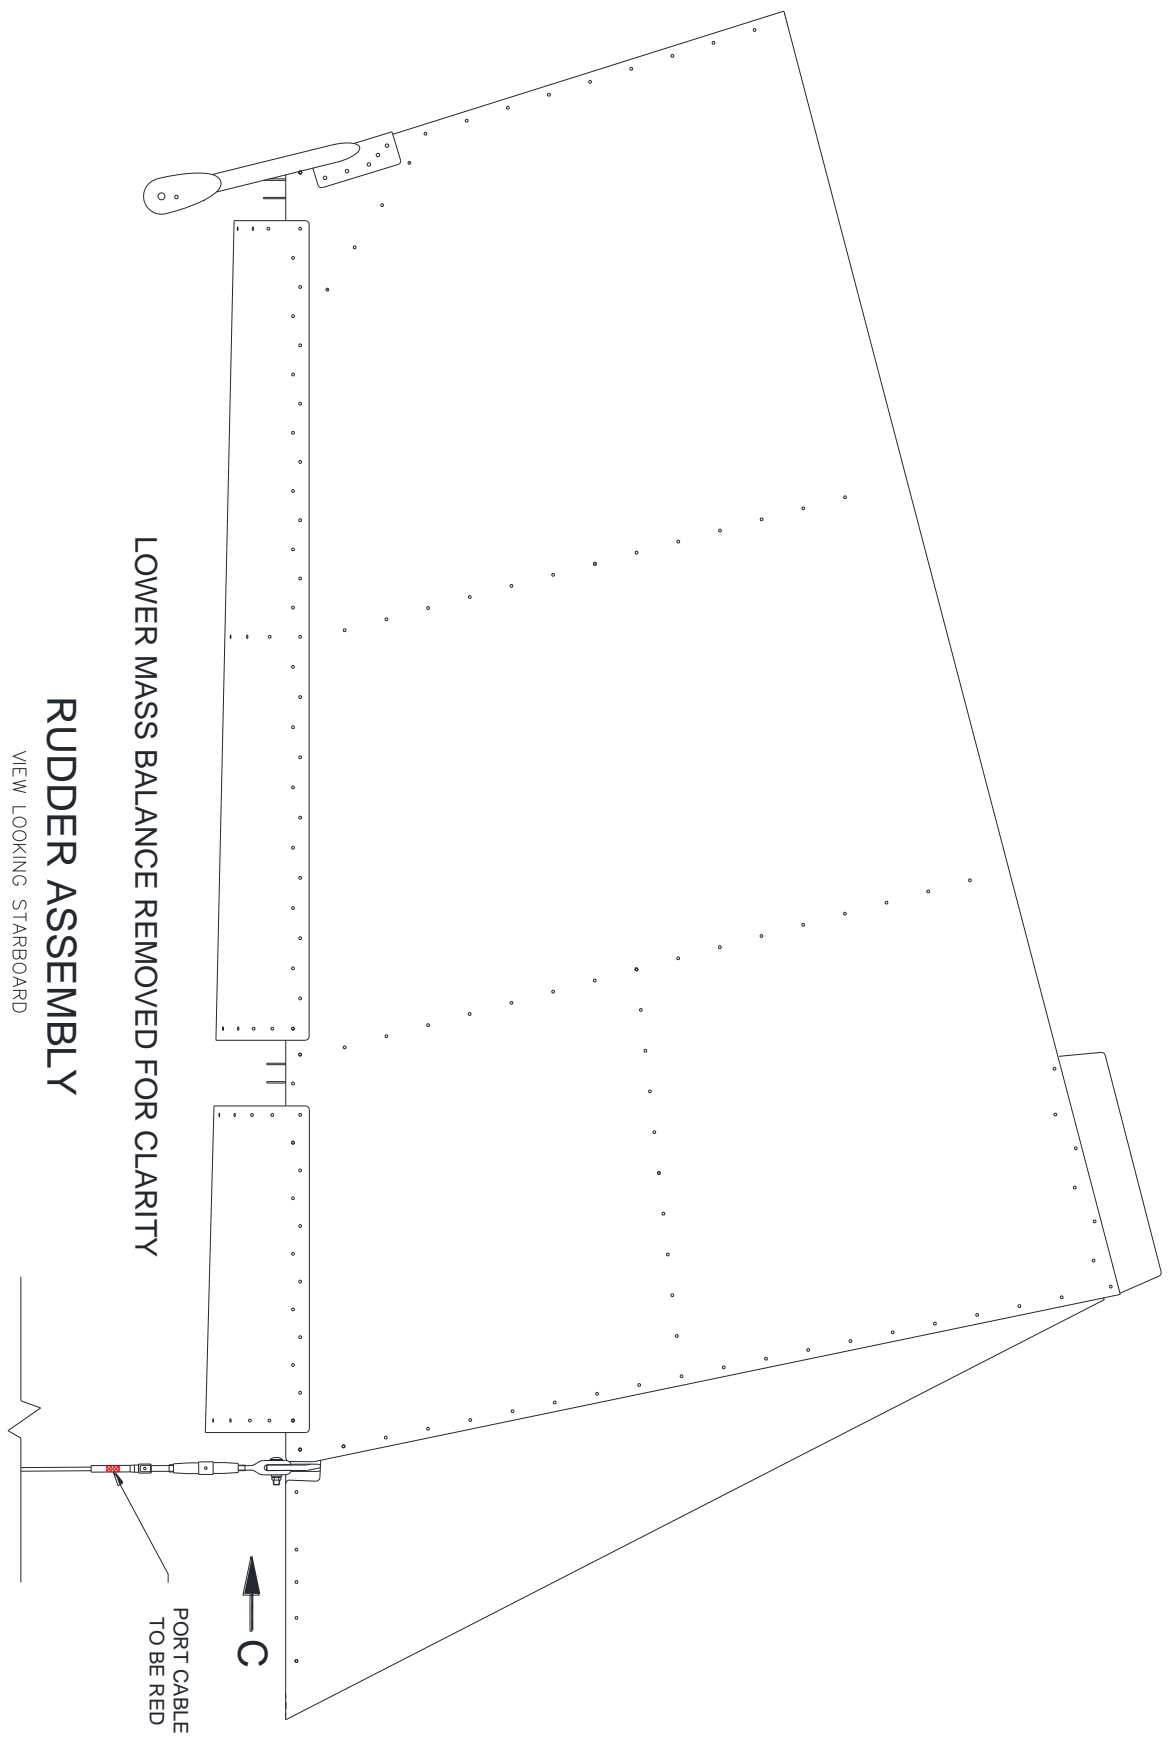
4. Inspect the rear end of the rudder cables for correct colour coding; starboard yellow and port red. It may be necessary to remove the circular access panel on the side of the rear tailcone between the bulkhead at station 229.75 and the aft bulkhead and/or articulate the rudder. If correct advance to step 6. Otherwise proceed with step 5.

5. Apply the correct colour coding to the rear end of the rudder cable assemblies using item 1 (YELLOW) for the starboard cable and item 2 (RED) for the port cable as depicted in Figure 5 and Figure 6. Removing any fairings, as required. Ensure any incorrect colour coding is completely obscured or removed. The rudder cables may have plastic sleeves to provide the colour coding.
