**SB-GA8-2023-215**

**Issue 3**

# Service Bulletin

Blower Fan Repair or Replacement

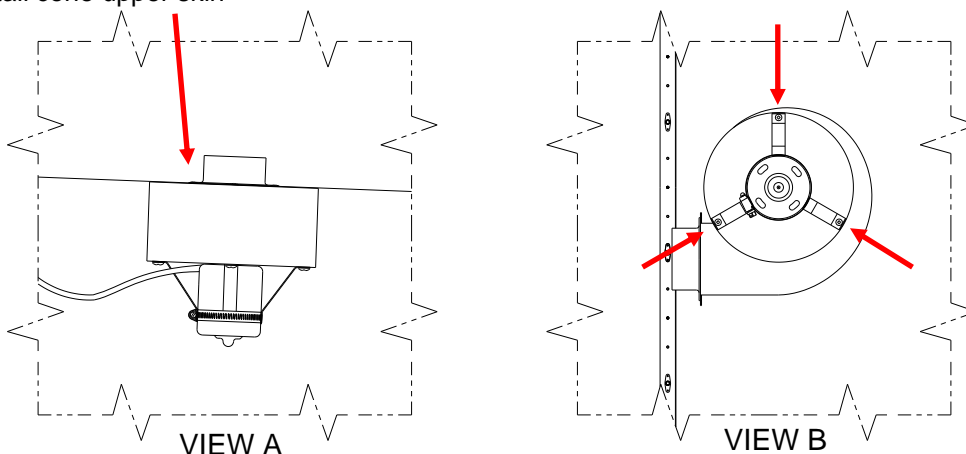
**Figure 2: Fan Installation Details**

Air inlet spigot fitted to exterior of tail cone upper skin
