**SB-GA8-2023-216**

# Service Bulletin

Relay Box Bonding

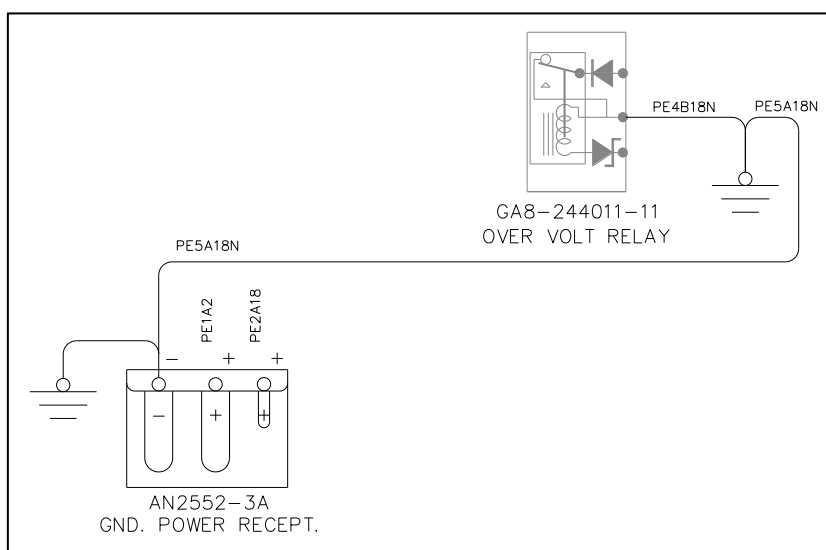
**Figure 2: Wiring Schematic**

This Service Bulletin provides instructions to inspect and, where required, install an electrical bonding connection between the main relay box and the aircraft earth. Poor bonding in this area may cause problems with the electrical equipment connected to Bus 1 or Bus 2 of the aircraft, such as degraded performance, errors, or intermittent failures.

- Using P/No. GA8-246015-053 (or locally fabricated equivalent), connect the earth terminals of the over-volt relay and ground power socket.
  - Bundle the new wire with the existing ground power connections. Ensure that wire is appropriately restrained and protected.
  - Connect wire to ground power receptacle, earth terminal in accordance with Figure 2.
  - Connect wire to relay box ground point in accordance with Figure 2 and Figure 3.
- After the mechanical connection is completed, measure the resistance for the new connection. Place one probe on the relay box ground point and the other on the engine frame or other suitable airframe earthing point. The resistance is required to be 0.1 ohms or less.
