Service Bulletin

Floor Rib 10 and 11 Reinforcement

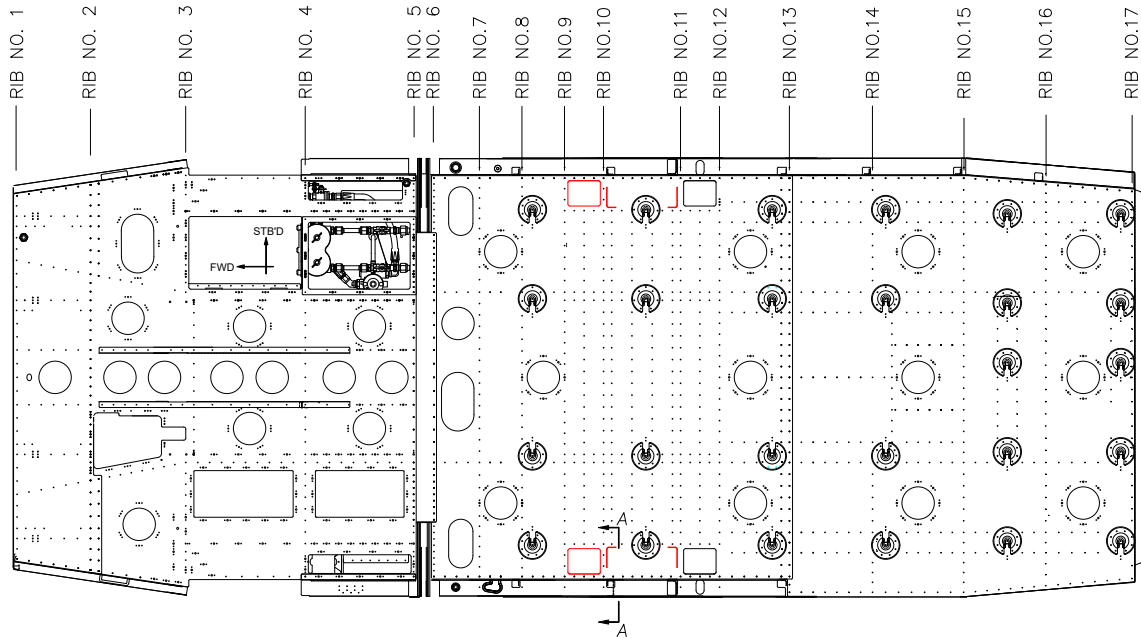
Figure 1: GA8 and GA8-TC 320 Floor Rib Locations (View looking down on Floor)

Floor ribs of the GA8 and GA8-TC 320 are numbered as shown in Figure 1. The affected rib locations, and the hatches which must be installed to access Rib #10 are marked in red.

- **Part A** of this Service Bulletin installs access panels to the floor and doublers to Rib #10 on the port and / or starboard side of the aircraft.
- **Part B** of this Service Bulletin installs doublers to Rib #11 on the port and / or starboard side of the aircraft.

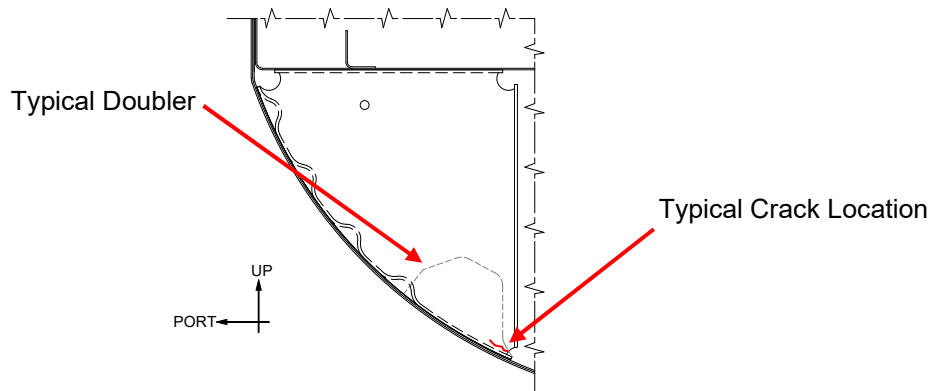
Figure 2: Section A-A: Typical Crack Location and Doubler Installation

This Service Bulletin provides instructions to install reinforcement doublers to the outboard floor ribs number 10 and 11. The doublers may be installed as a preventative measure for aircraft operating from unprepared runways or may be used to repair cracks in the affected ribs.

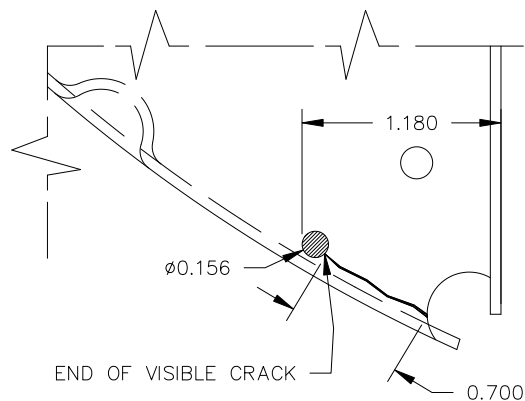
Figure 3: Maximum Crack Size

Where this Service Bulletin is being used to address cracks in Rib #10 and #11, the cracks must be less than 0.700" in length and, including a $\varnothing 0.156$ " stop-drill, be less than 1.180" when measured from the rib flange, as shown in Figure 3.
