Service Bulletin

Alternate Air Cable Inspection

GA8 serial numbers GA8-07-115 through GA8-08-130.

Document: Service Bulletin SB-GA8-2008-44,
Issue 2

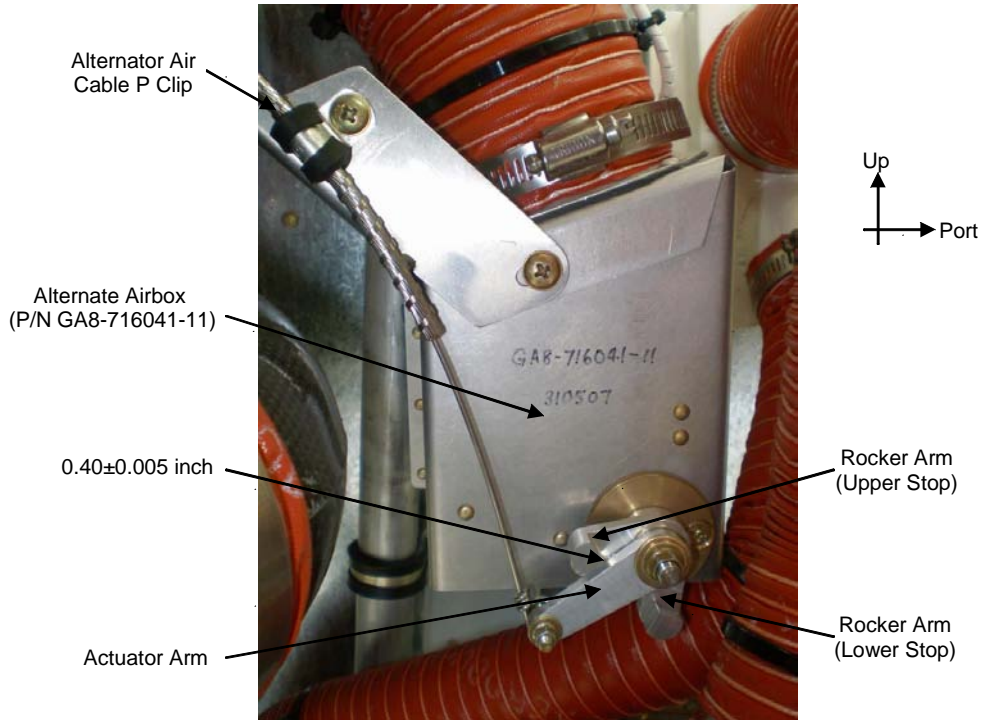
- 1.1. Remove the port side engine cowl access panel to gain access to the alternate air box.
- 1.2. With the alternate air knob fully in, there should be a gap of 0.40 ± 0.005 inch between the actuator arm and the upper stop of the rocker arm (see Figure 1). If the actuator arm is closer to the lower stop of the rocker arm (see Figure 2) with the alternate air knob fully in, complete the **2. Modification Procedure** detailed in this Service Bulletin. If the cable is installed correctly, on the Document Compliance Notice, record completion of the inspection procedure with no defect noted.

Figure 1 Correct Cable Installation

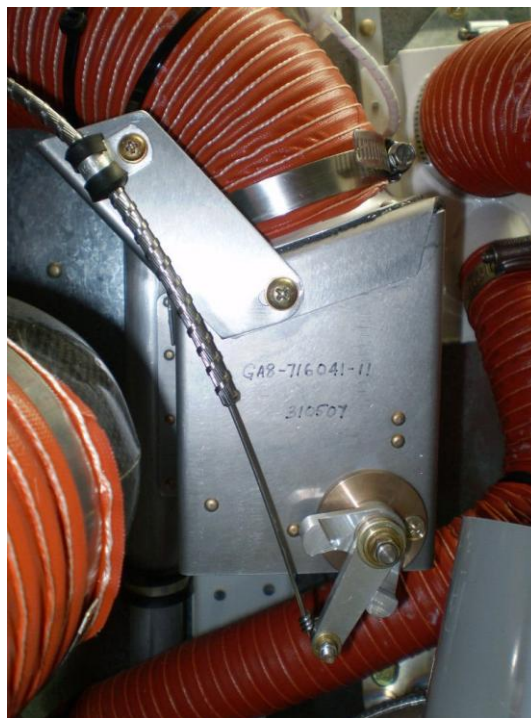
There is a possibility that the automatic alternate air door in the revised alternate air box (P/N GA8-716041-11) may be inhibited by the manual override cable, reducing the effectivity of the automatic alternate air door.

Figure 2 Incorrect Cable Installation

- 2.1. Loosen the P clip securing the alternate air cable to the air box such that the cable outer sleeve can move freely through it.
- 2.2. With the alternate air knob held in, feed the cable through the P clip until there is a gap of 0.040 ± 0.005 inch between the actuator arm and the upper stop of the rocker arm, and then tighten the P clip securing the alternate air cable to the air box.
- 2.3. Check for correct operation several times (refer to the **1. Inspection Procedure** in this Service Bulletin).
- 2.4. Reinstall the port side engine cowl access panel.
- 2.5. Record completion of the modification procedure on the Document Compliance Notice.
