SB-GA8-2012-81

Issue 3

Service Bulletin

Modifications required for aircraft to be registered in Malaysia

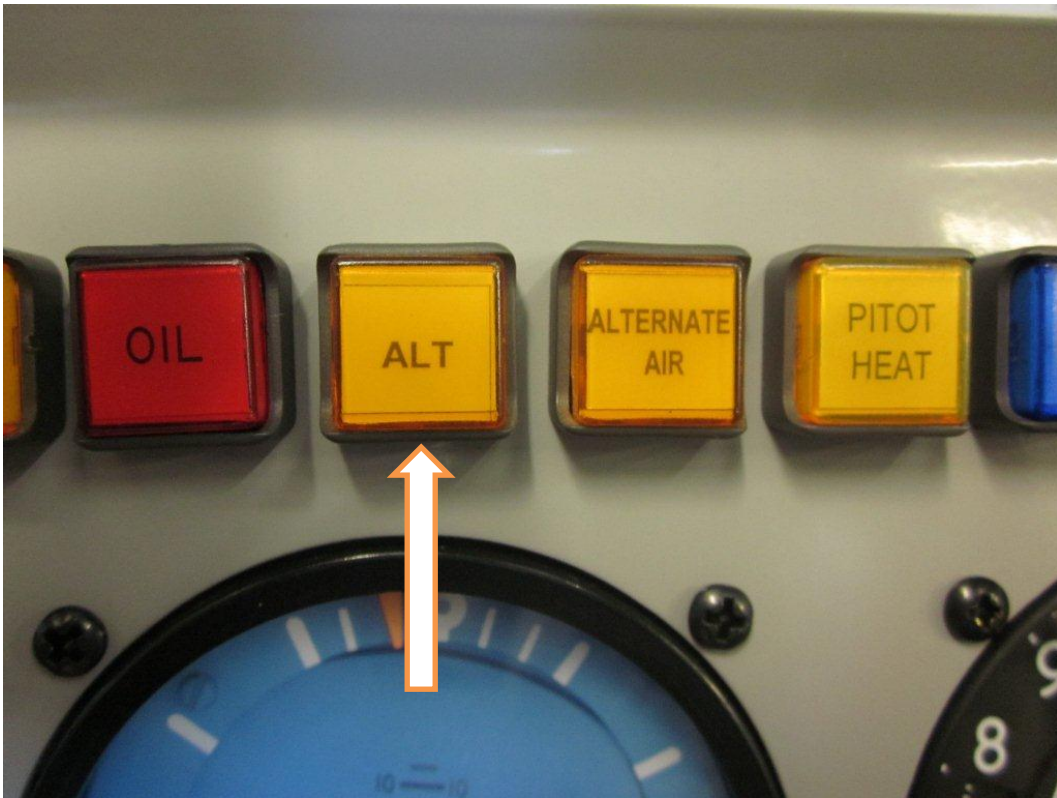
Figure 1 : “Amber” ALT indicator

1. So as to comply with Department of Civil Aviation Malaysia Airworthiness Notice No 72 Issue 2, the existing amber ALT lens is to be changed to red. This modification may be performed with the flight instrument panel in situ.

2. The aircraft Bus 1 and Bus 2 Master switches located in the overhead electrical panel are to be turned off.
3. The ALT annunciator is shown in Figure 1 as fitted to a typical flight instrument panel. Carefully remove the amber housing. Discard the amber housing.

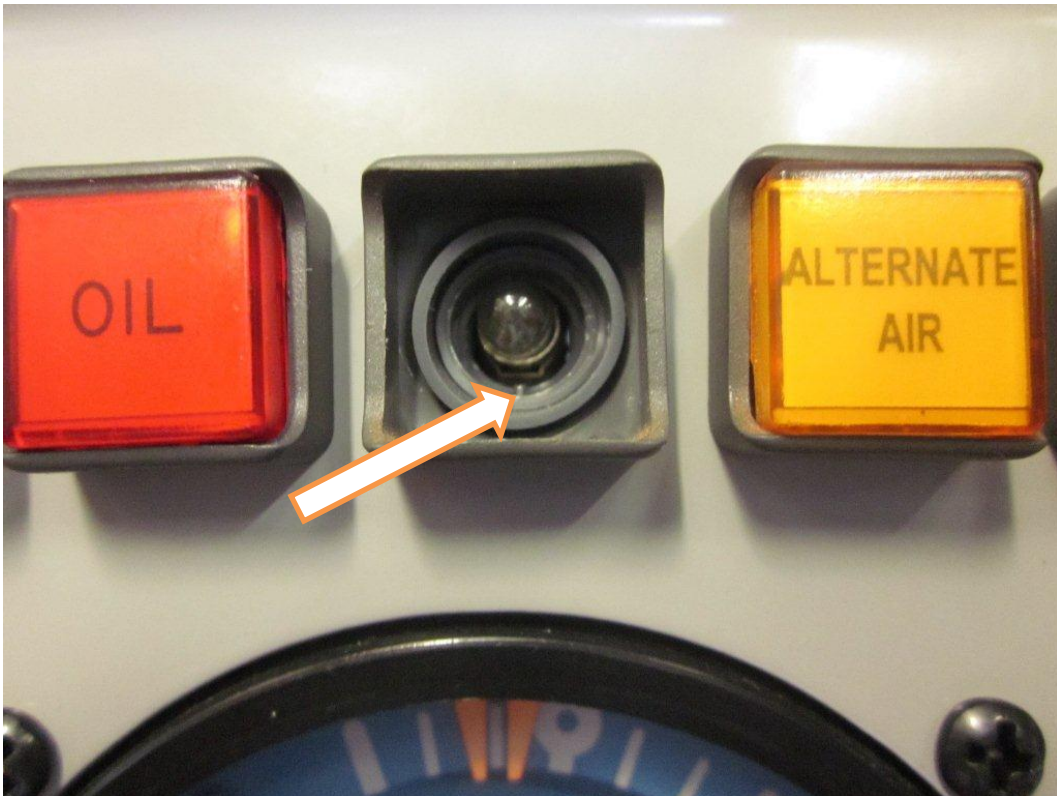
Figure 2 : Lenses removed from ALT indicator

4. Take note of the keying used within the lamp housing. Refer to Figure 2. When assembling the red lens, white diffuser and placard, ensure that the keying of the diffuser and housing match. Refer to Figures 3 and 4.

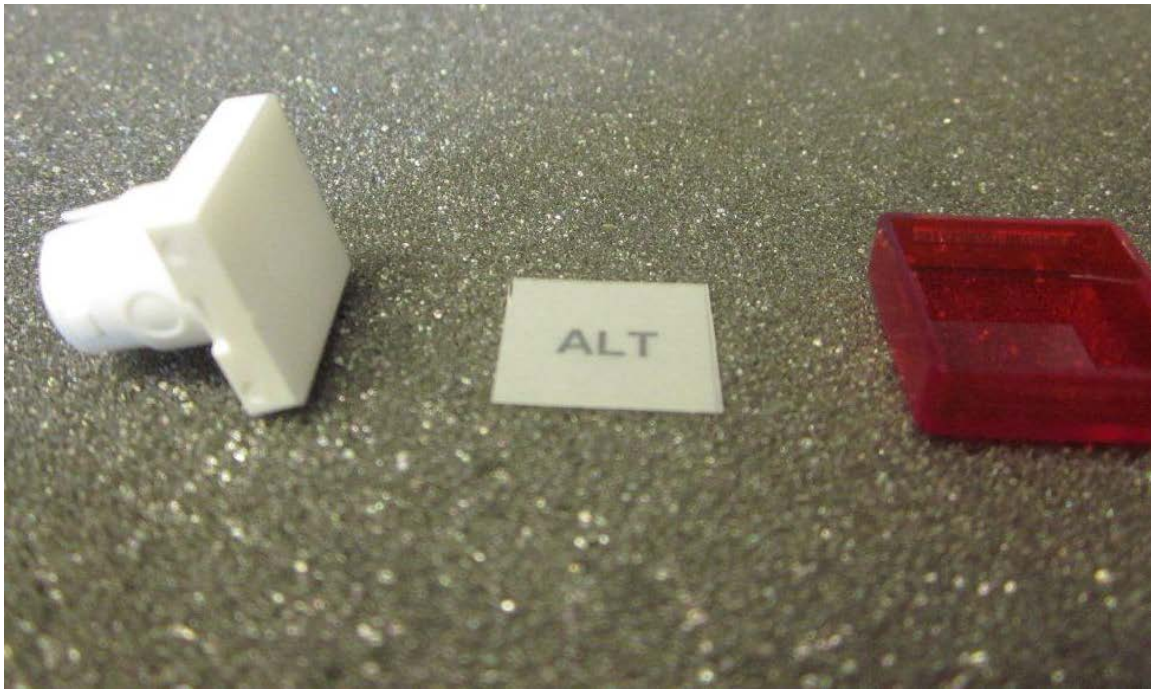
Figure 3 : Disassembled diffuser, placard and lens cover.

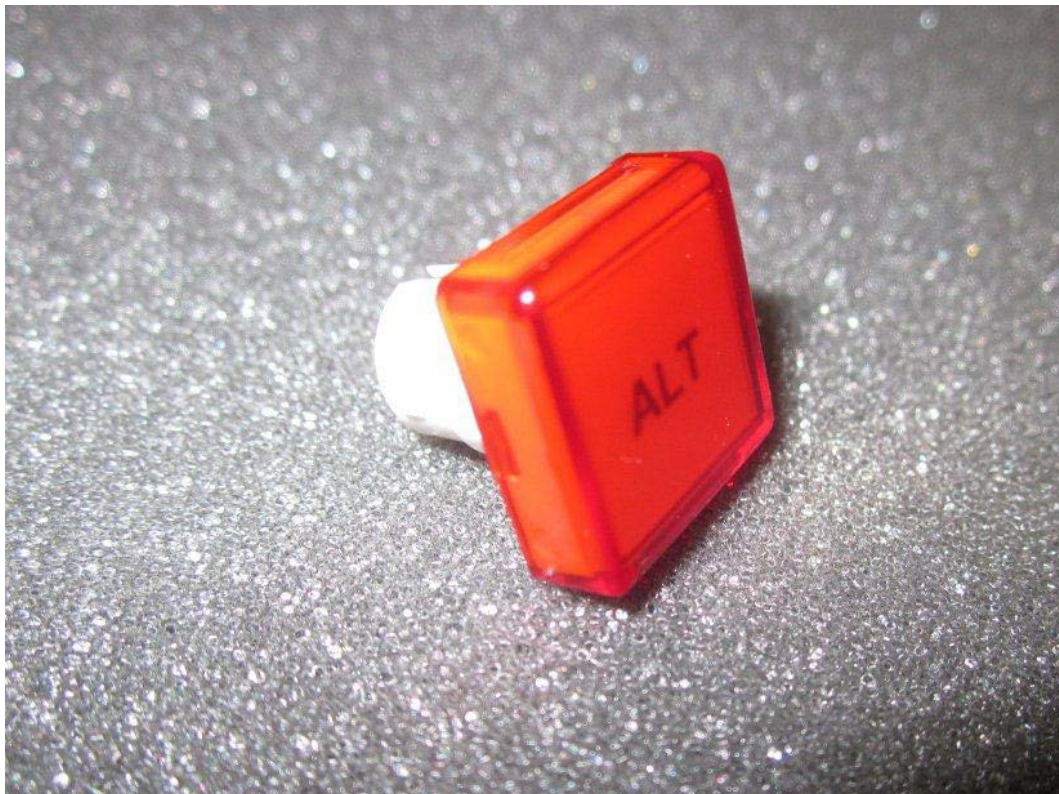
Figure 4 : Assembled diffuser, placard and lens cover.

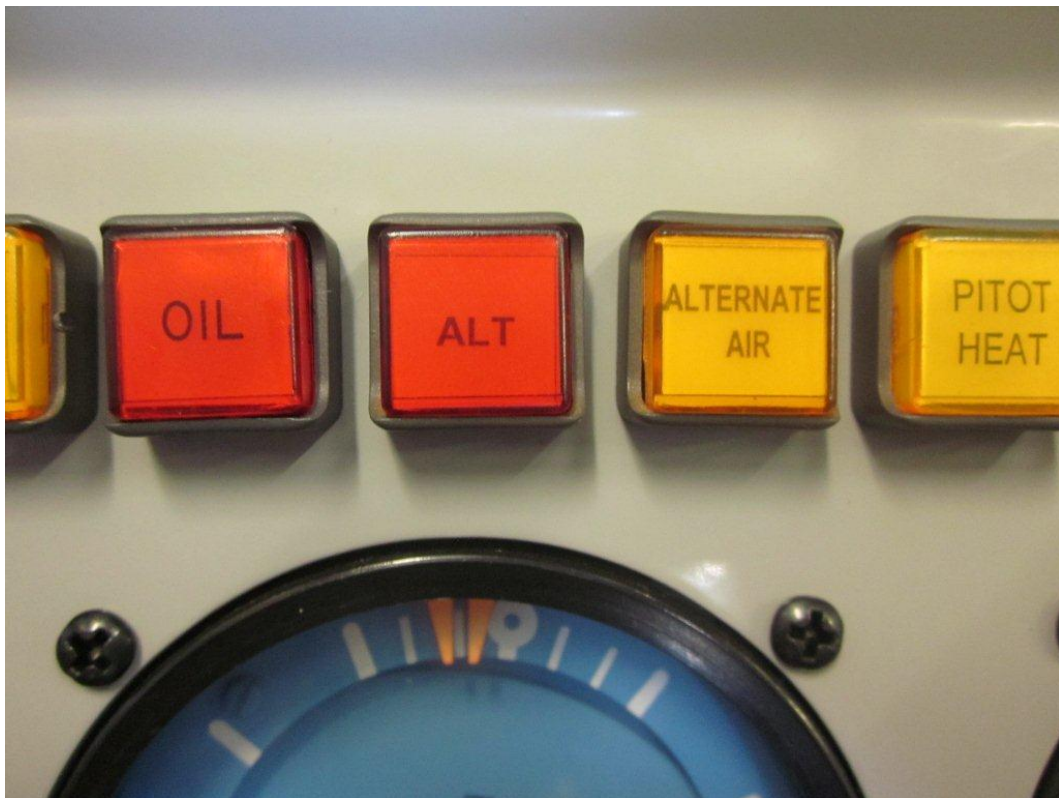
Figure 5 : Completed modification.

5. Fit the red ALT lamp cover (item 1) as shown in Figure 5.
6. Apply power to the aircraft by switching on Bus 1 and Bus 2 Masters.
7. Undertake a lamp test from the flight instrument panel. The push-button test lamp is located on the top right hand side of this panel. The red ALT lamp should be illuminated when operating from the aircraft battery. Switch off Bus 1 and Bus 2 Master switches.
