SB-GA8-2012-77

Issue 4

Service Bulletin

Pitot Heat Connector at wing tip

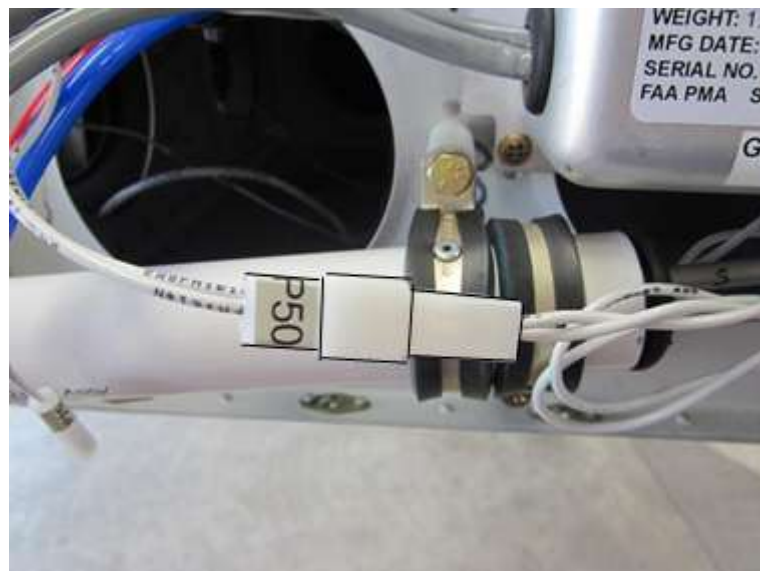
GippsAero has received reports of a burnt 2 way connector used for the pitot heater in the left hand wing tip. The heat resulting from such a failure may damage the pitot or static tubes

Figure 1 – View of connector P50.

1. Remove the left hand wing tip from the aircraft. Wing tip removal instructions are provided in Section 57-30-00 of the Service Manual. **NOTE:** Take care as wiring to the Strobe/Nav light is still connected.
2. The electrical connection of P50 & J50 (Figure 1) must not be disconnected at this point in time. Look for signs of charring or discolouration of the connector housing. Inspect for signs of damage to the pitot or static lines in the near vicinity of the electrical connector.
3. In accordance with the directions stated in the Compliance statement of this Service Bulletin, Part 2 of this Service Bulletin is to be carried out. If carrying out Part 2 of this Service Bulletin immediately, proceed to Part 2, Step 2.

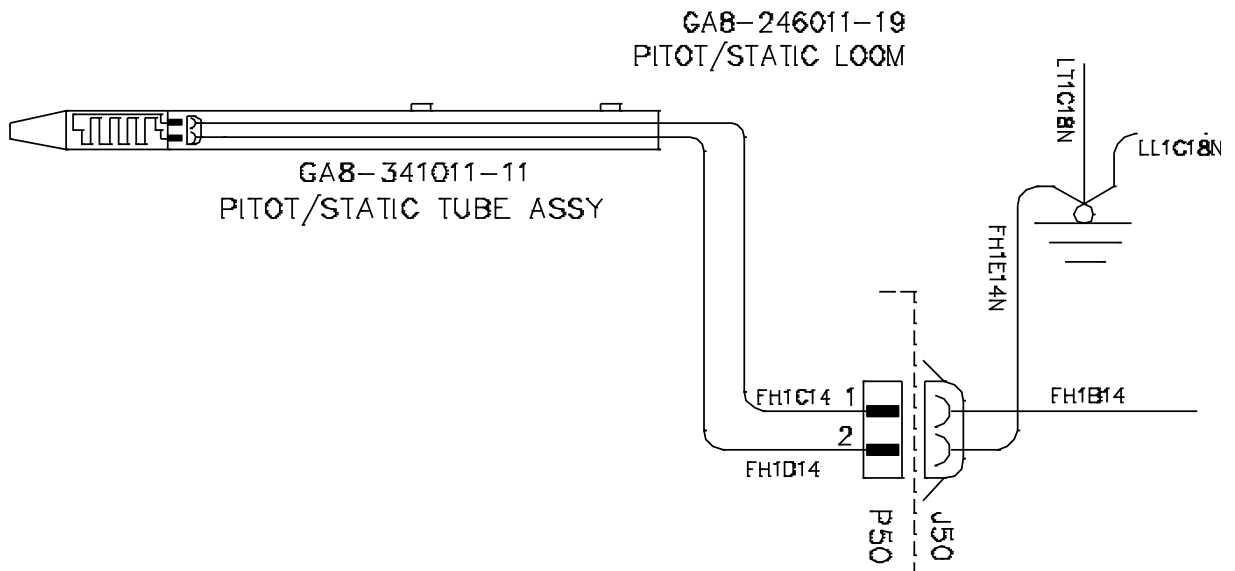
Figure 2 – Unmodified wiring to the pitot static tube assembly.

1. Remove the left hand wing tip from the aircraft. Wing tip removal instructions are provided in Section 57-30-00 of the Service Manual. **NOTE:** Take care as wiring to the Strobe/Nav light is still connected.
2. The standard aircraft wiring to the heated pitot is shown in Figure 2. The modified wiring is shown in Figure 3.

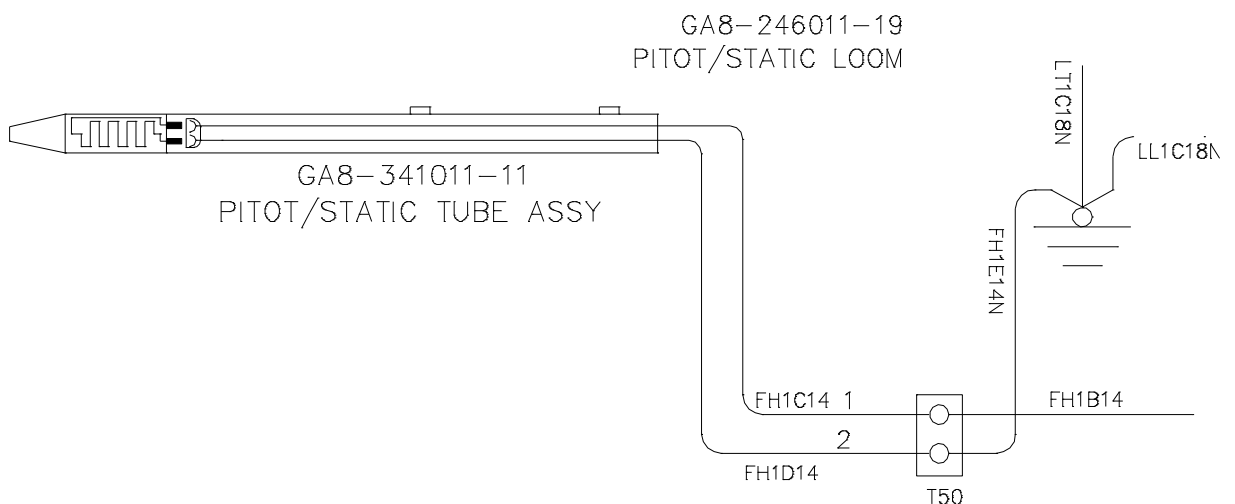
Figure 3 - Modified wiring to the pitot static tube assembly.

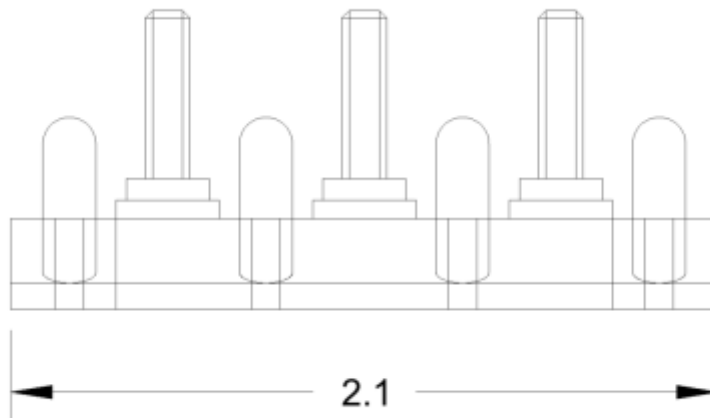
Figure 4 - Dimensions of modified terminal strip.

3. Discard connector housings P50 and J50, and cut-off the spade terminals.
4. Fit item 2. Alternatively item 14 may be modified in accordance with Figure 4. This can be done by using a hacksaw. File away any "plastic" burring.

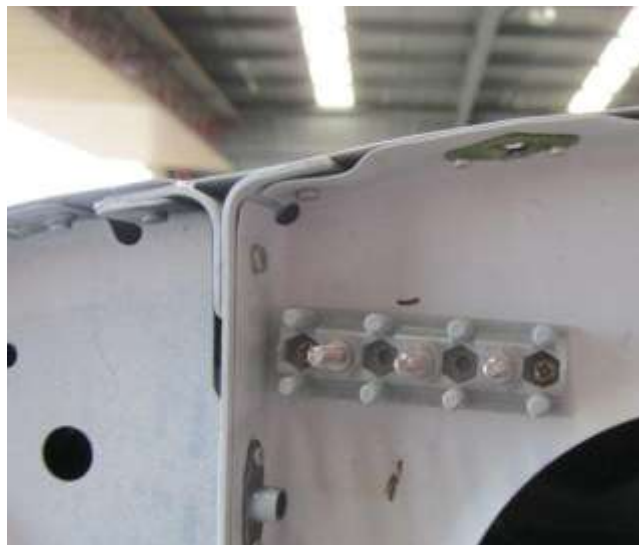
Figure 5 - Terminal Strip installed (item 2).

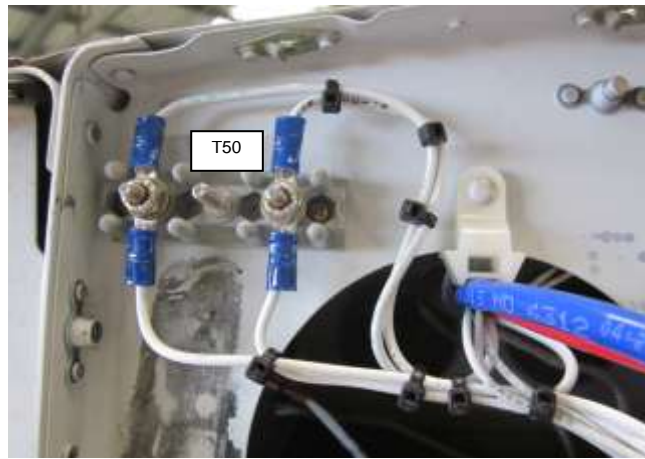
Figure 6 - Ring terminals fitted.

5. Crimp the ring terminals (item 8) to the wire leads.
6. Screw wire FH1C14 and wire FH1B14 to one stud.
7. Screw wire FH1D14 and wire FH1E14N to the second stud.
8. Placard "T50" to be fixed in near vicinity of the terminal strip.
9. Fit the terminal cover as shown in Figure 7. Use either item 1 or items 12 and 13 cut to length as shown in Figure 8.

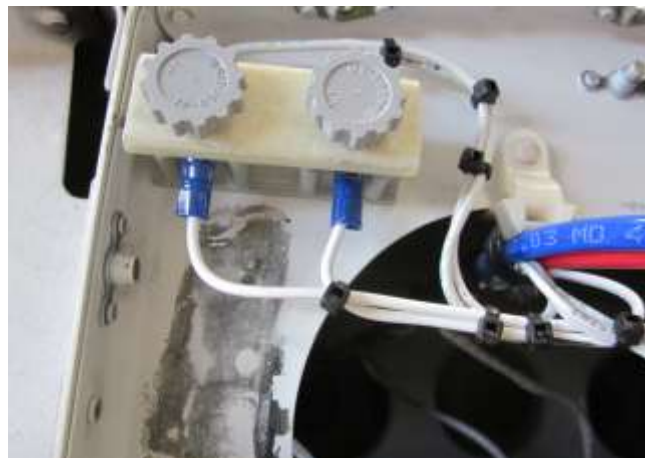
Figure 7 - Terminal Cover fitted (item 1).

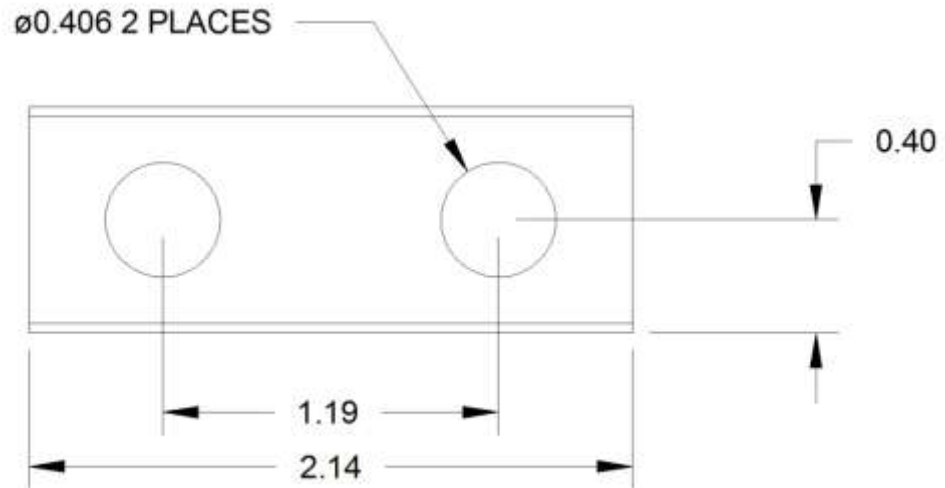
Figure 8 – Dimensions for modified cover.
