SB-GA8-2015-126

Service Bulletin

Inspection of the Crankcase Breather Tube

All GA8 & GA8-TC 320 aircraft up to and including serial number GA8-TC 320-15-212

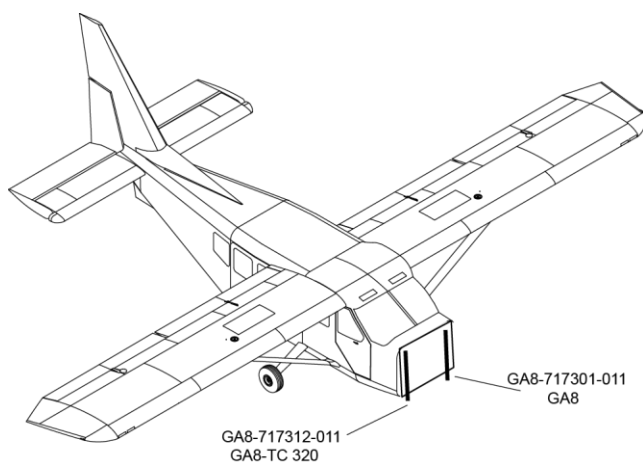
Figure 1: Breather Tube Locations

An instance of Crankcase Breather Tube blockage due to icing has occurred during cold weather operations. All GA8 and GA8-TC aircraft require an inspection of the breather tube to ensure the bypass hole has been included at manufacture.

1. Remove the engine cowls as required in accordance with the applicable Service Manual.
2. Identify the installed location of the Crankcase Breather Tube as shown in Figure 1. Perform a visual inspection of the Tube and determine if a bypass hole exists. If the bypass hole does exist, check to ensure that the Breather Tube and bypass hole are clear of obstructions and fill out the compliance note document at the end of this Service Bulletin. If no bypass hole exists, proceed to Step 3.

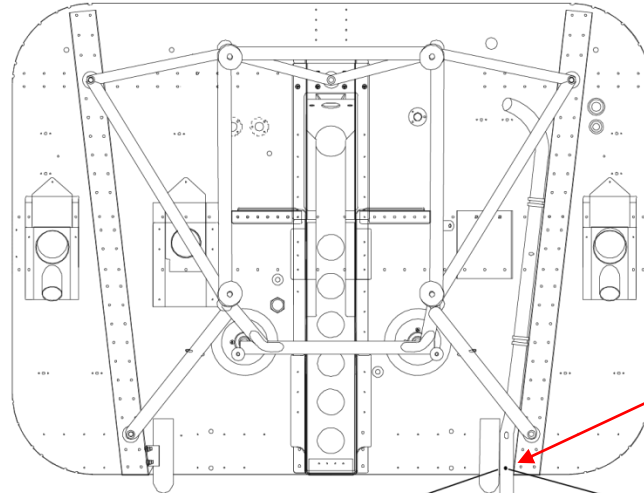
Looking aft at Firewall GA8

Weld between Hot Air Outlet and Breather Tube

Bypass Hole (Flute)

Drill 1/4" hole

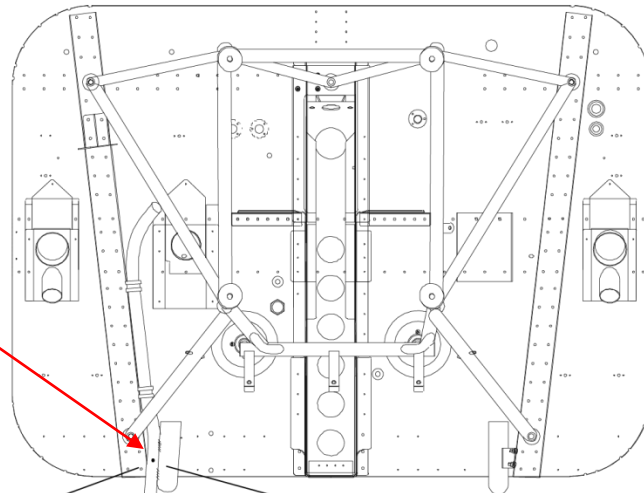
Looking aft at Firewall GA8-TC 320

Bypass Hole (Flute)

Weld between Hot Air Outlet and Breather Tube

Drill 1/4" Hole
