Service Letter

Uneven fuel feed from wing tanks.

All GA8 aircraft.

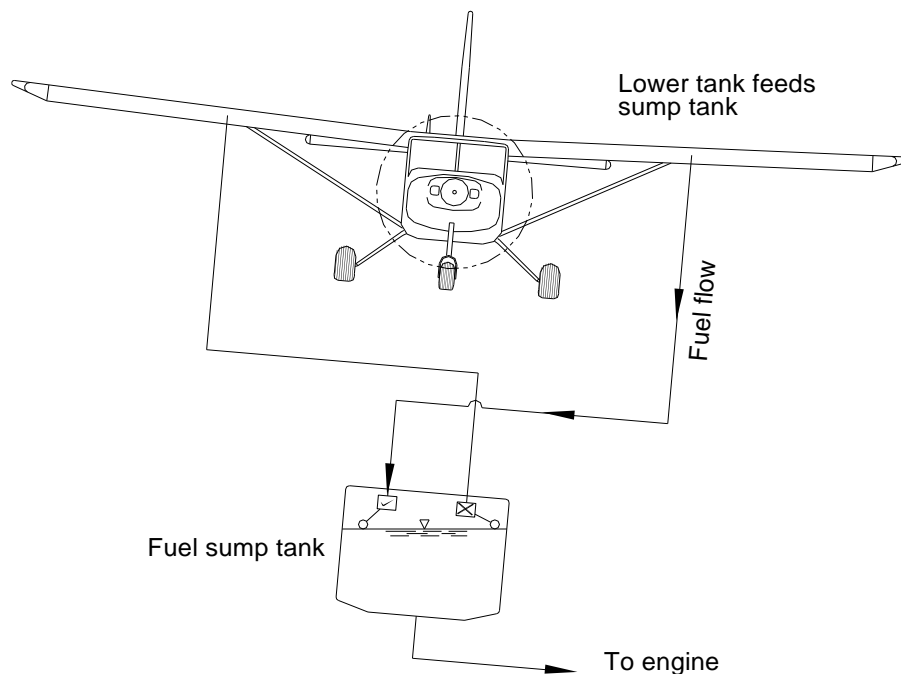
Figure 1

The Fuel management system Gippsland Aeronautics has designed for the Airvan, when setup correctly, will feed fuel evenly from both wing tanks throughout a flight. By using a pair of float valves in the sump tank, fuel feed from each tank can be regulated. Fuel from each tank is supplied to the sump tank via crossed over feed lines, i.e. the left wing tank feeds fuel to the right float valve in the sump tank and vice versa; the purpose of this design feature is to ensure that if a wing heavy condition exists due to more fuel in one tank than the other fuel will be used from the lower (heavy) wing as shown.

Flying with the (heavy) wing low will cause the fuel level in the sump tank to be such that fuel will feed from the lower (heavy) wing. Trying to feed from a full tank by holding it high, has the opposite and undesirable effect in the Airvan.

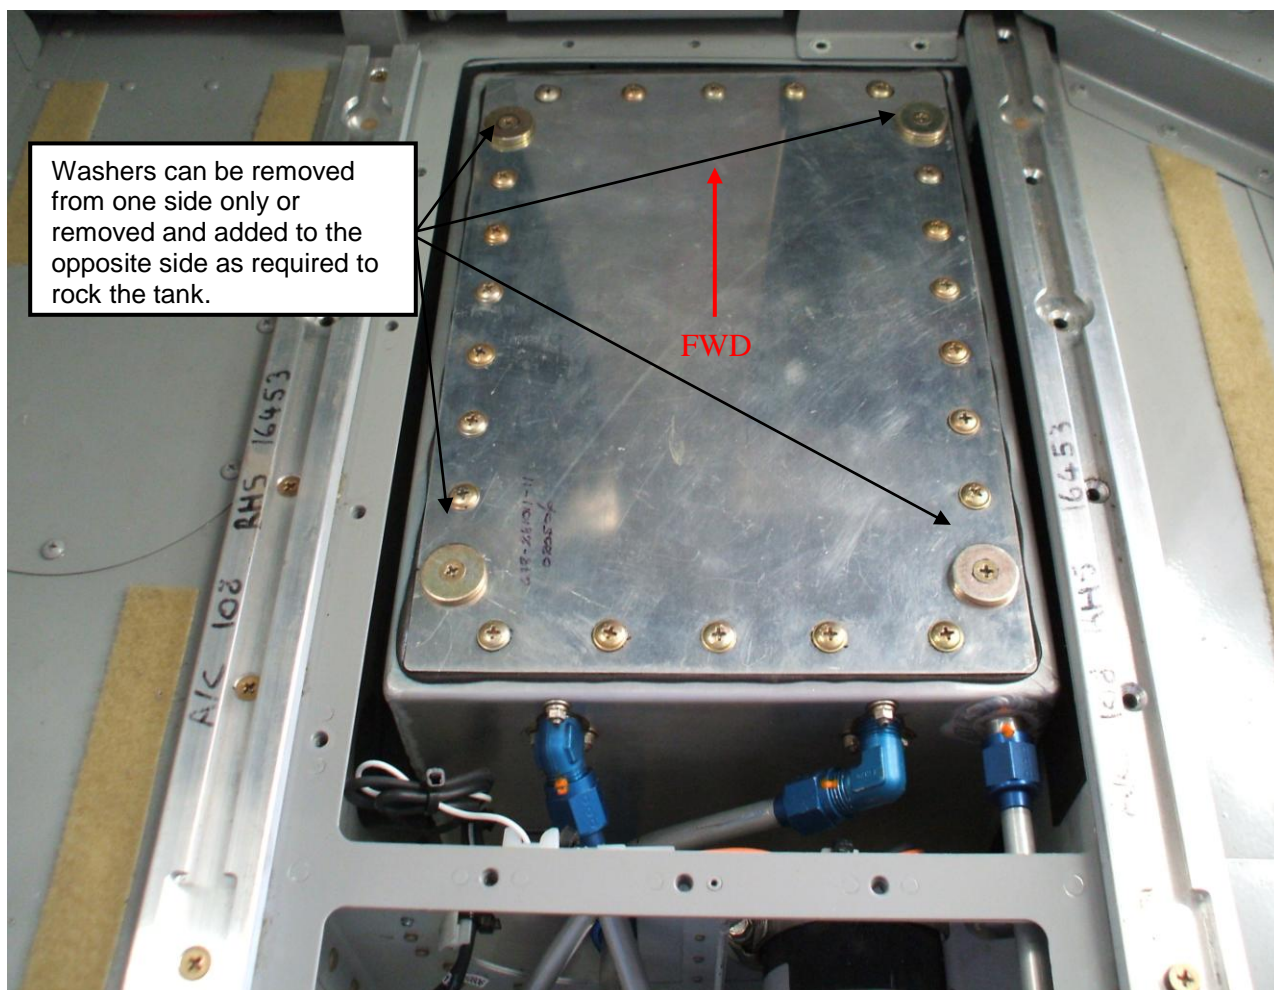
The tank is held in its lateral position by washers fitted to the top of the tank (shown in Figure 2), these washers bear against the bottom of the cover panel.

If the sump tank does not have AN970-3 washers installed as shown in Figure 2 they can be installed by counter sinking 4 x AN970-3 washers to suit the heads of MS24694S50 screws, these screws are then used to retain the washers.

3. By adjusting the position of these washers from side to side the lateral level of the tank can be adjusted.
4. Removing washers from the left side of the tank will cause the tank to rock to the right; removing washers from the right side will cause the tank to rock left.

5. Washers can be removed from one side only or removed and added to the existing washers on the other side as required to achieve the desired amount of lateral movement. The collector tank should be rocked or biased towards the tank that remains fullest or is having the least amount of fuel used from it.
